Asbestos Materials Survey

Prepared for:	Abril
Prepared by:	Karim Nazemi Licensed Asbestos Assessor #001359 Trinitas Group
Site	1st Dundas Scout Hall
Address:	Yates Avenue, Dundas Valley NSW 2117
Date:	Thursday, 31 August 2023

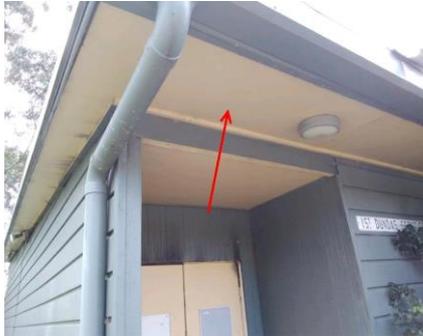
Photo No: 230831-133207
 Result: Asbestos - Positive
 Location-Level: Exterior - Ground Floor
 Room-Location: Building eaves throughout
 Feature-Material: FC sheeting
 Item No - Risk Rating: 1 - Low

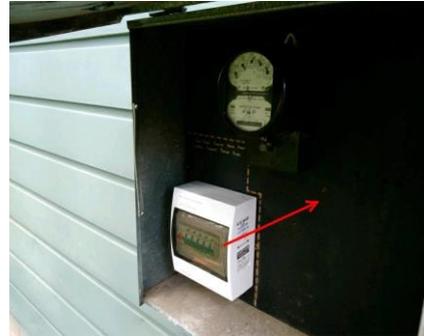
Photo No: 230831-134031
 Result: Asbestos - Presumed Positive
 Location-Level: Interior - Ground Floor
 Room-Location: West side, electricity meter box
 Feature-Material: Electrical backing board
 Item No - Risk Rating: 2 - Low

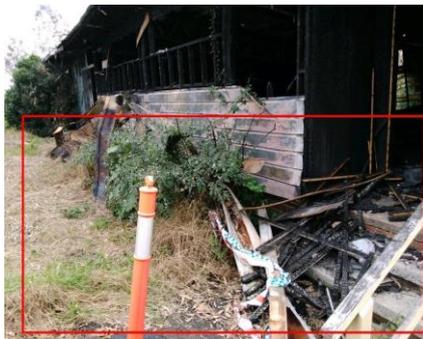
Photo No: 230831-134050
 Result: Asbestos - Positive
 Location-Level: Exterior - Ground Floor
 Room-Location: Southwest corner, debris on ground surface
 Feature-Material: FC fragments
 Item No - Risk Rating: 3 - High

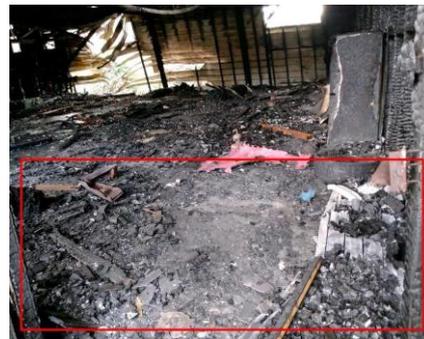
4	Interior	Ground Floor	South-east corner, debris on floor (partially inspected due to unsafe structure)	Asbestos	FC fragments	Similar to 02	Presumed Positive	230831-135813	100	Poor	Friable	High	High	No	P1	P1 - Restrict access to area & organise remediation works as soon as practicable & manage any remaining

Photo No: 230831-135813
 Result: Asbestos - Presumed Positive
 Location-Level: Interior - Ground Floor
 Room-Location: South-east corner, debris on floor (partially inspected due to u safe structure)
 Feature-Material: FC fragments
 Item No - Risk Rating: 4 - High

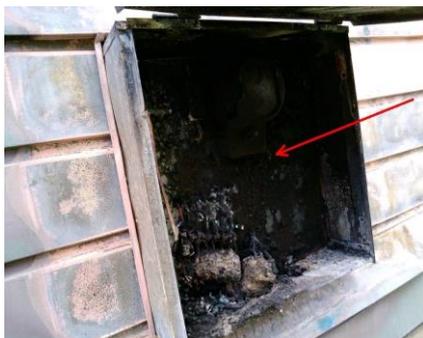
Photo No: 230831-134131
 Result: Asbestos - Presumed Positive
 Location-Level: Exterior - Ground Floor
 Room-Location: East side, electricity meter box, fire damaged
 Feature-Material: Electrical backing board
 Item No - Risk Rating: 5 - High

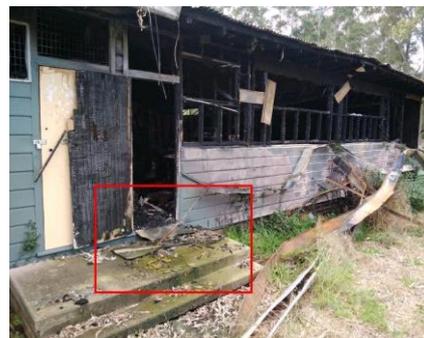
Photo No: 230831-134216
 Result: Asbestos - Presumed Positive
 Location-Level: Exterior - Ground Floor
 Room-Location: South side, external areas adjacent kitchen
 Feature-Material: FC fragments
 Item No - Risk Rating: 6 - High

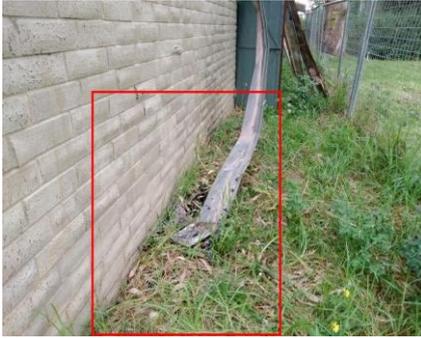
Photo No: 230831-135903
 Result: Asbestos - Positive
 Location-Level: Exterior - Ground Floor
 Room-Location: North side, fire damage debris on ground surface
 Feature-Material: FC fragments
 Item No - Risk Rating: 11 - High

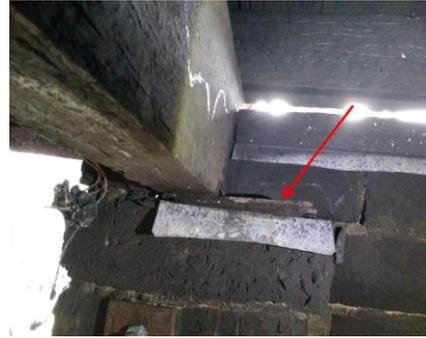
Photo No: 230831-140719
 Result: Asbestos - Positive
 Location-Level: Interior - Sub-floor
 Room-Location: Subfloor throughout, Packers on piers
 Feature-Material: FC fragments
 Item No - Risk Rating: 12 - Low

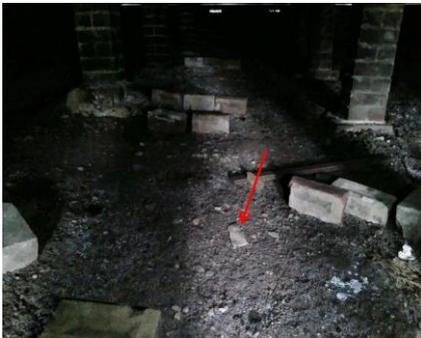
Photo No: 230831-140857
 Result: Asbestos - Presumed Positive
 Location-Level: Interior - Sub-floor
 Room-Location: Subfloor surface, fragments on surface
 Feature-Material: FC fragments
 Item No - Risk Rating: 13 - Low

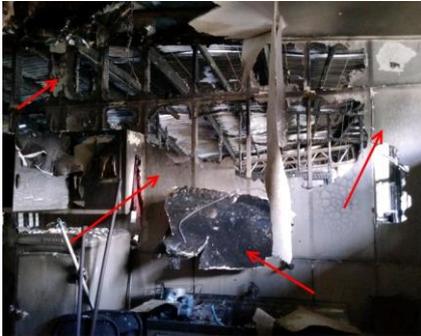
Photo No: 230831-134405
 Result: Asbestos - Negative
 Location-Level: Interior - Ground Floor
 Room-Location: Internal wall linings in the western section (not fire damaged)
 Feature-Material: Masonite like material

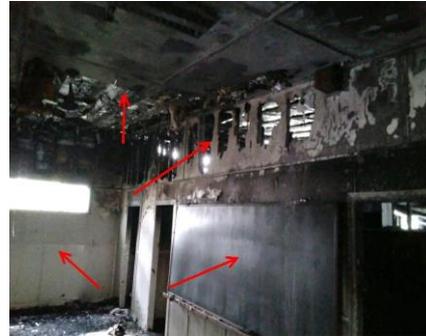
8	Interior	Ground Floor	Internal wall linings in the western section (not fire damaged)	Asbestos	Masonite like material	Similar to 03	Presumed Negative	230831-134441								
9	Interior	Ground Floor	Kitchen, vinyl flooring	Asbestos	Vinyl flooring	04	Negative	230831-134901								
10	Interior	Ground Floor	Internal wall linings in the western section (not fire damaged)	Asbestos	Masonite like material	Similar to 03	Presumed Negative	230831-134915								
11	Exterior	Ground Floor	North side, fire damage debris on ground surface	Asbestos	FC fragments	05	Positive	230831-135903	30	Poor	Friable	High	High	No	P1	P1 - Restrict access to area & organise remediation works as soon as practicable & manage any remaining materials as part of an AMP
12	Interior	Sub-floor	Subfloor throughout, Packers on piers	Asbestos	FC fragments	06	Positive	230831-140719	Through out	Good	Non-Friable	Low	Low	No	P4	P4 - No short term remediation works required. Review periodically and manage as part of an AMP

Photo No: 230831-134441
 Result: Asbestos - Presumed Negative
 Location-Level: Interior - Ground Floor
 Room-Location: Internal wall linings in the western section (not fire damaged)
 Feature-Material: Masonite like material

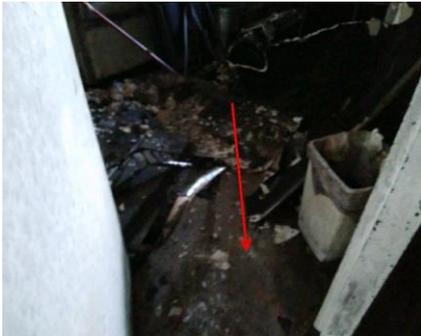
Photo No: 230831-134901
 Result: Asbestos - Negative
 Location-Level: Interior - Ground Floor
 Room-Location: Kitchen, vinyl flooring
 Feature-Material: Vinyl flooring

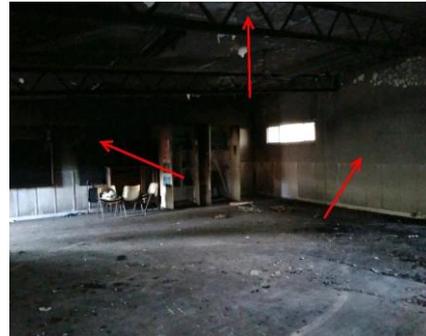
Photo No: 230831-134915
 Result: Asbestos - Presumed Negative
 Location-Level: Interior - Ground Floor
 Room-Location: Internal wall linings in the western section (not fire damaged)
 Feature-Material: Masonite like material

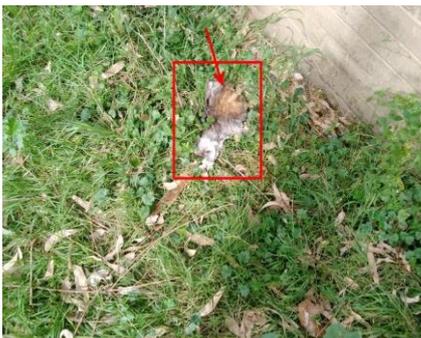
Photo No: 230831-140906
 Result: Asbestos - Presumed Negative
 Location-Level: Exterior - Ground Floor
 Room-Location: North side, Insulation material
 Feature-Material: SMF like material

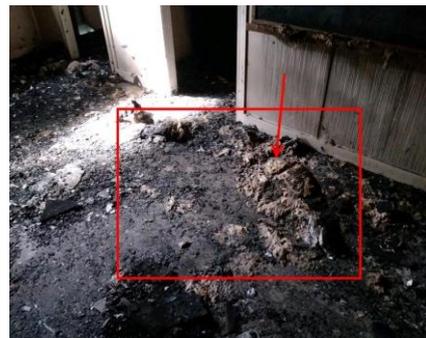
Photo No: 230831-140909
 Result: Asbestos - Presumed Negative
 Location-Level: Interior - Ground Floor
 Room-Location: Western section, insulation material on floor
 Feature-Material: SMF like material
