# Arboricultural Impact Assessment

Murray Farm Scout Hall (11 Haines Ave, Carlingford)

For Nimbus Architecture + Heritage

Susan Stratton Landscape Architects Pty Ltd  
23 February 2022

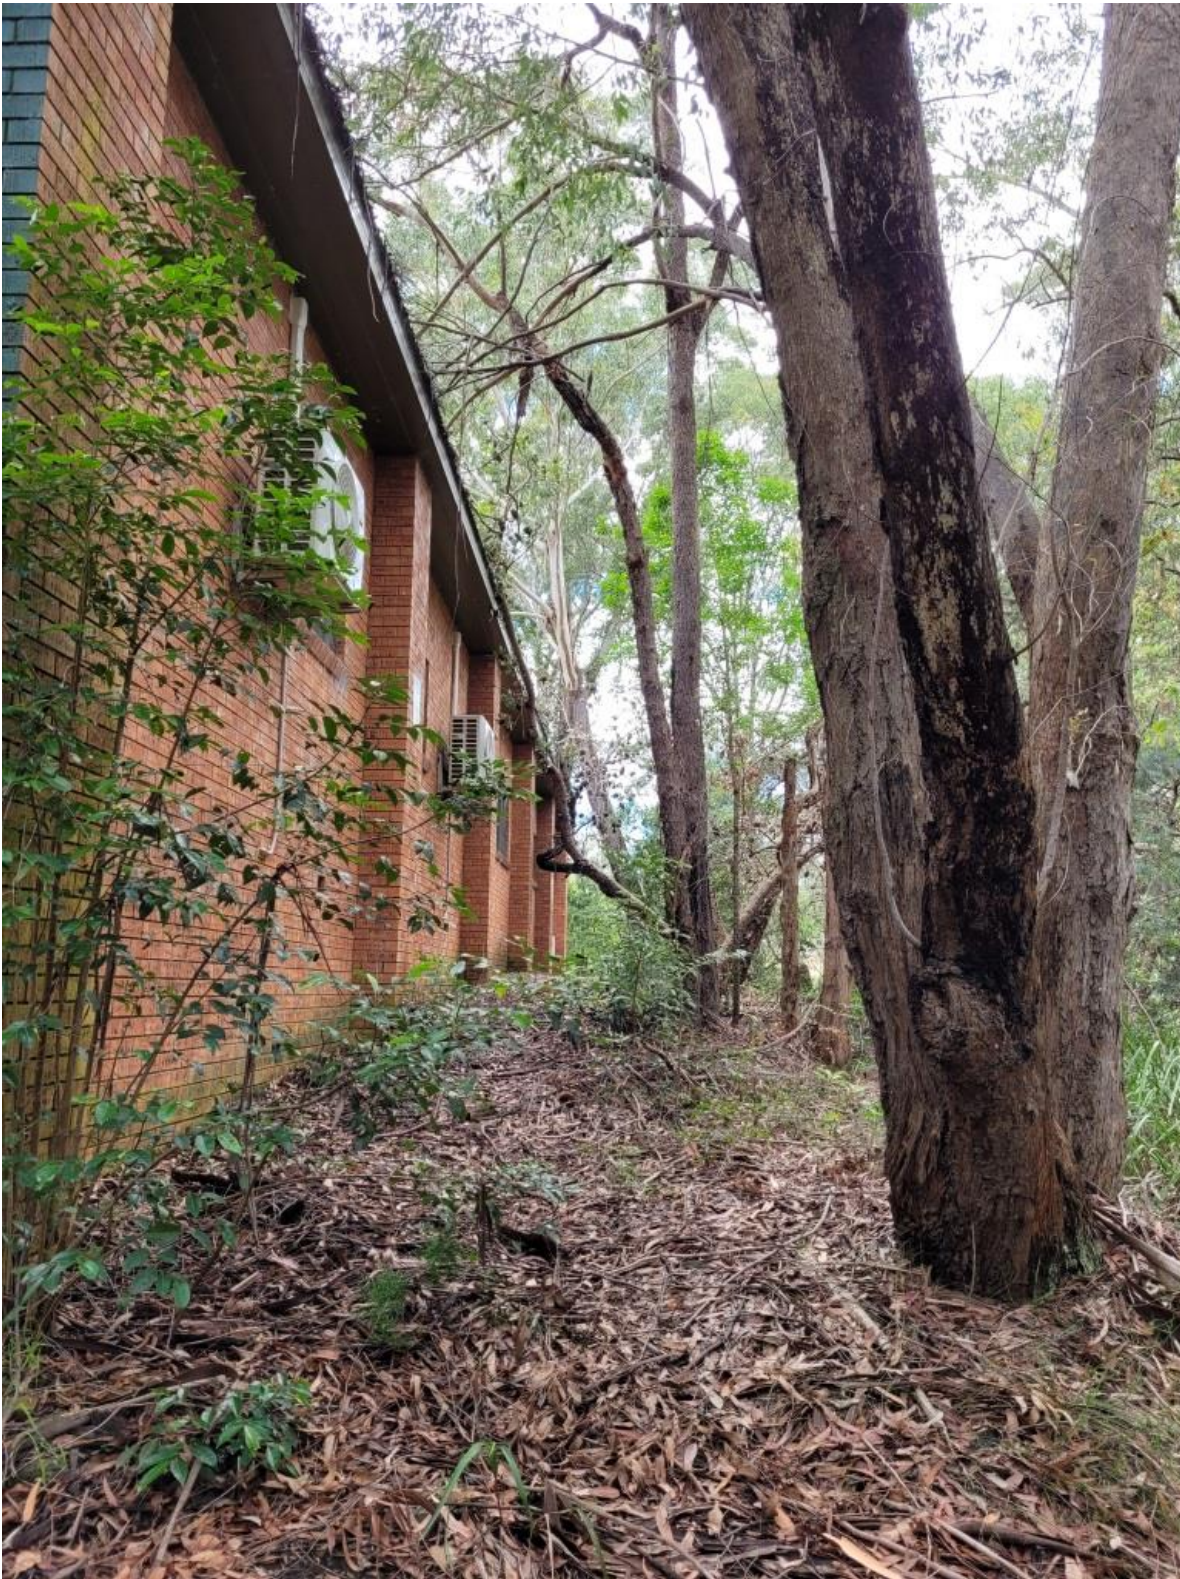
Figure 1 Trees 6-11 are located at the rear of the building, within the APZ and many have structural deficiencies necessitating their removal.

- 5.1.1 **Tree Removals.** Trees T1A, T2, T2A, T6, T7, T8, T8A, T8B (dead tree), T10, T10A, T11, T11A, T11B, T12, T17 (dead tree), T18A, T21, T21A, T21C, T24, T26, T26A, T26B and T27A are to be removed due to structural deficiencies and/or they are located within the APZ of the Scout Hall and do not warrant retention. Removals to be in accordance with Section 3.0 Tree Removal of the Tree Management Plan **Appendix E**. Extraction of the felled timber will be difficult and further consultation with the Site Arborist will be required to ensure trees to be retained are not impacted.

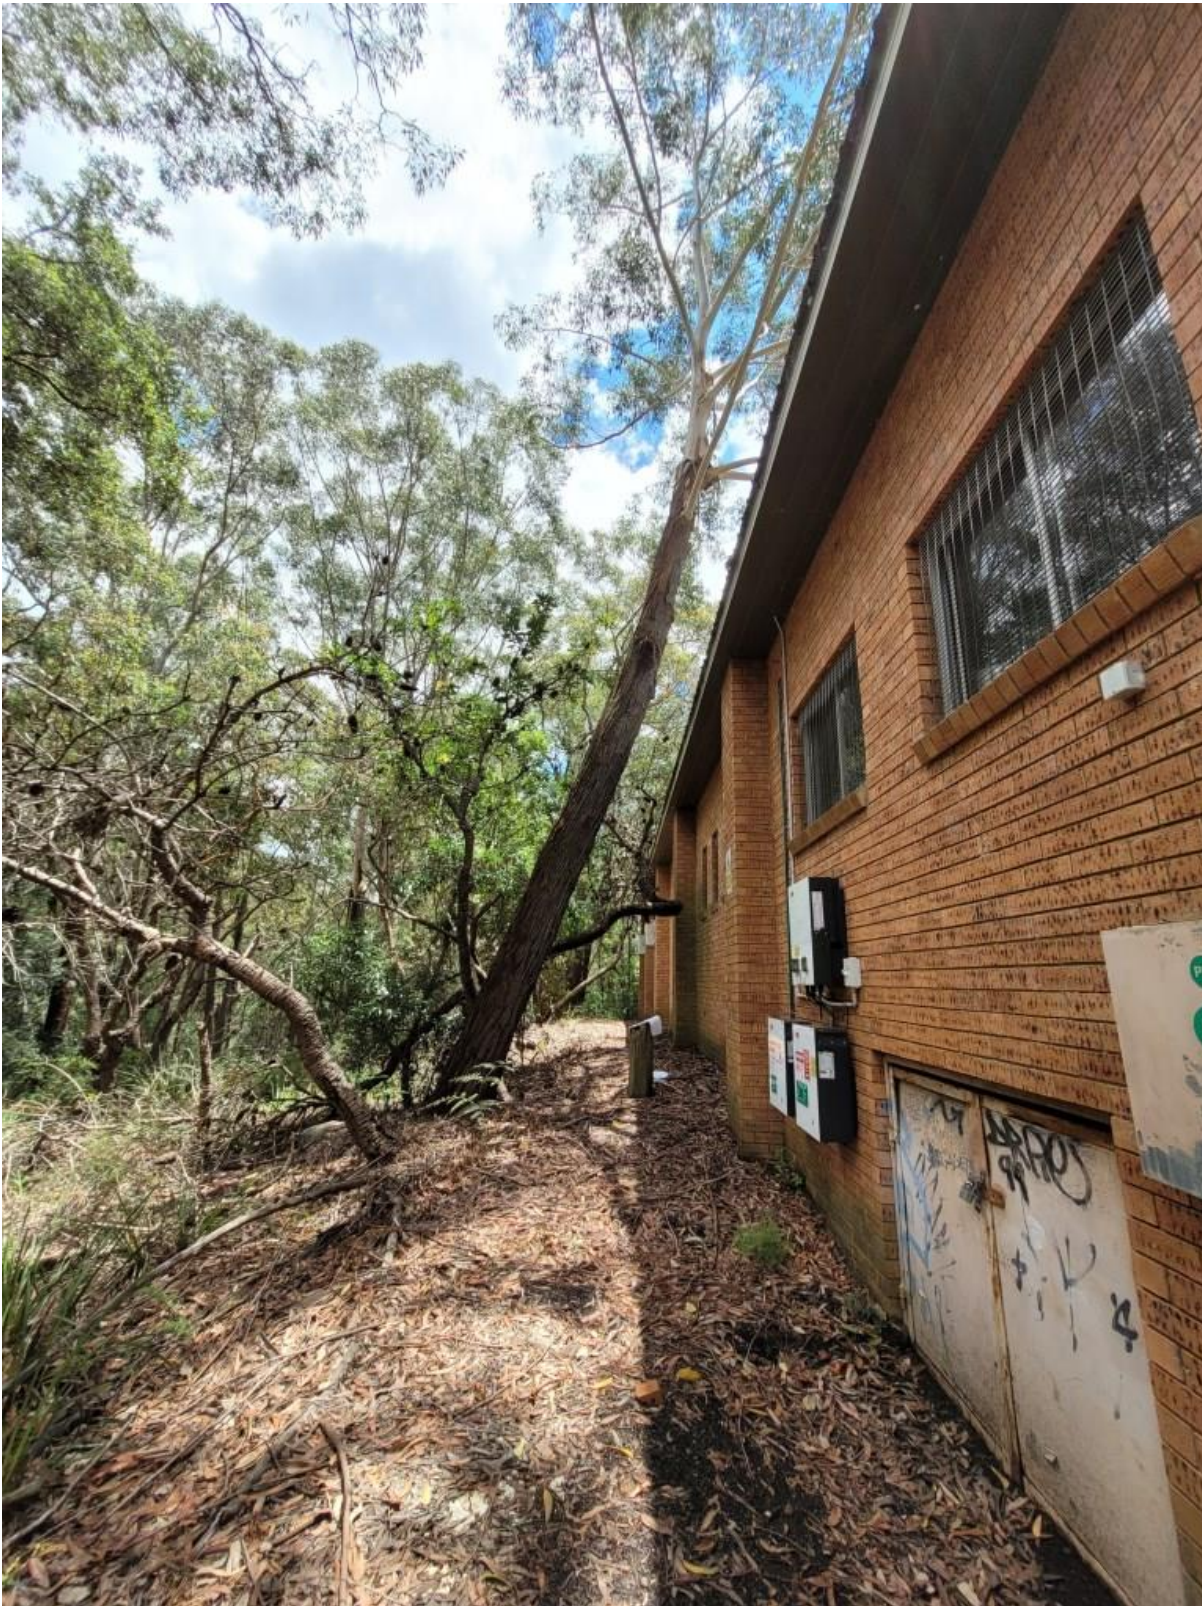
Figure 2 Tree 11 is located at the rear of the building, within the APZ and many have structural deficiencies necessitating removal.

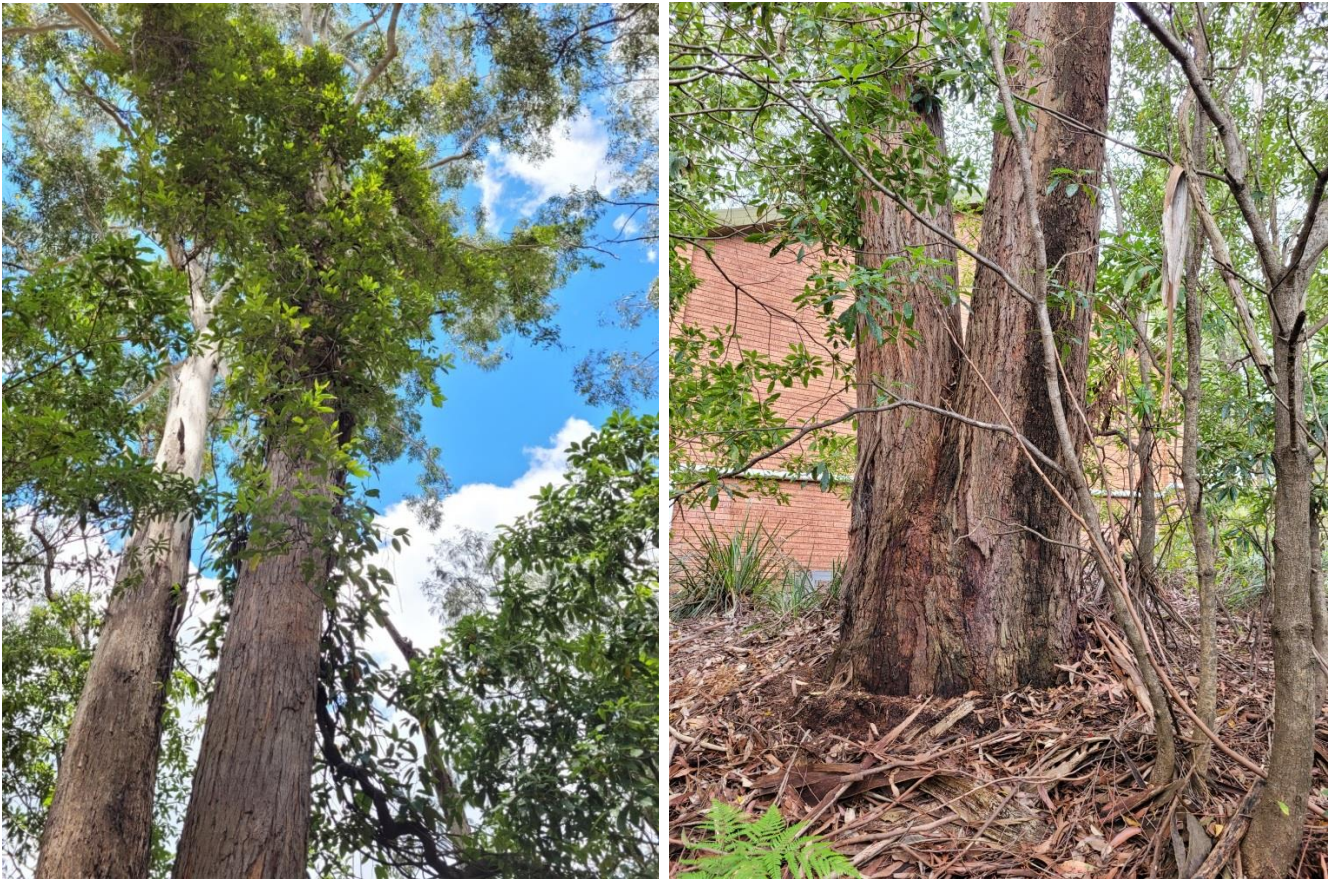
Figure 3 + 4 Tree 16 is located within the APZ however it warrants retention. Vines can be seen in the canopy.

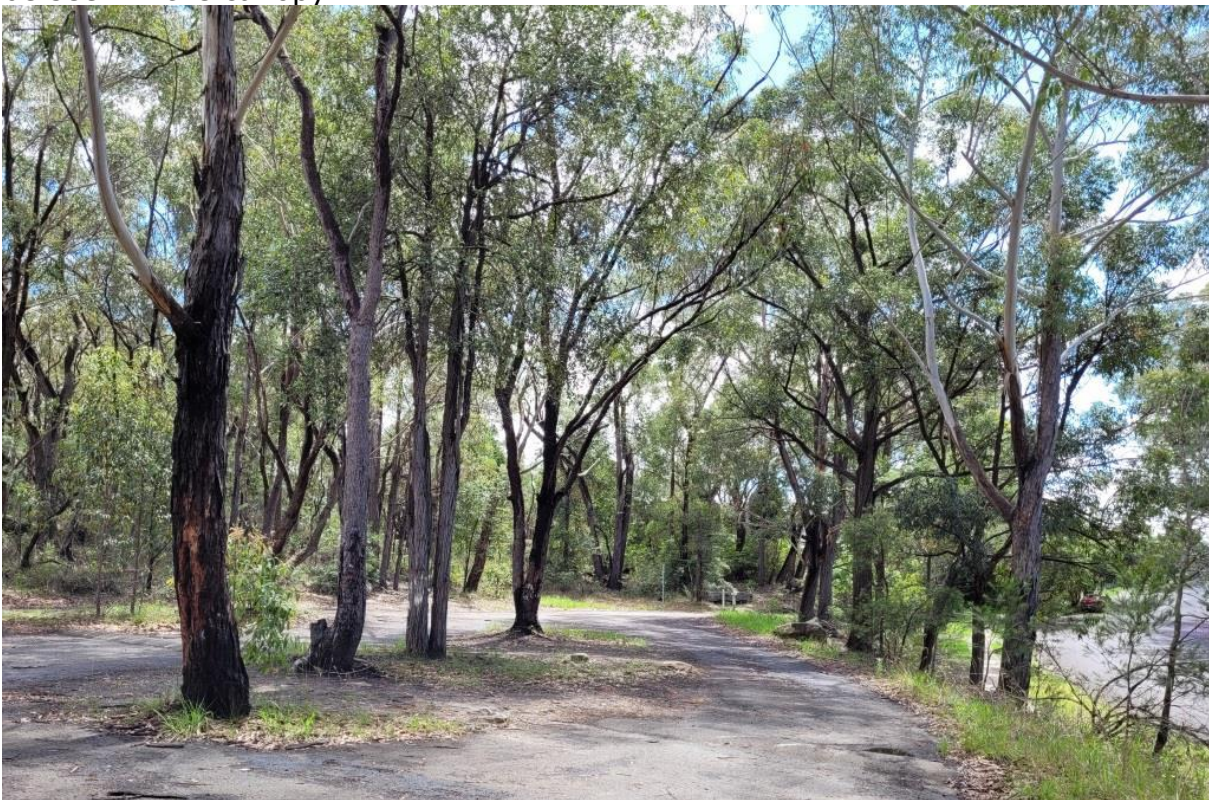
- T31 (Blackbutt) was found to have decay at the base and fungal conks were evident. Mechanical damage from vehicles damaging the trunk has likely led to the infection by pathogens. This tree located in the carpark will need to be monitored. Barriers preventing vehicles from causing further damage and parking around the base of this tree would be beneficial.

- T28A, T28B and T33 (all Blackbutts), T29(Turpentine) and T32(Bloodwood) are all located within unprotected islands within the carpark. Barriers preventing vehicles from causing mechanical damage and parking around the base of these trees would be beneficial to the long term health of the trees and reduce the incidence of damage due to vehicles caused by branch drop.

Figure 5 Trees 29 – 32 located in an island in the carpark require protection from vehicles. Tree 31 in the foreground has a fungal fruiting body at the base and further assessment is required.

- Monitoring of the following trees located in the car park is recommended:- T28 (Blackbutt), T30 (Bloodwood), T31 (Blackbutt)
- 5.1.5 Trees located within islands within the carpark T27, T28, T28A, T28B, T29, T30, T31, and T32 would benefit from the installation of barriers preventing vehicles from causing mechanical damage and parking around the base of these trees. The incidence of damage to vehicles parked immediately beneath the trees caused by branch drop may also be reduced.

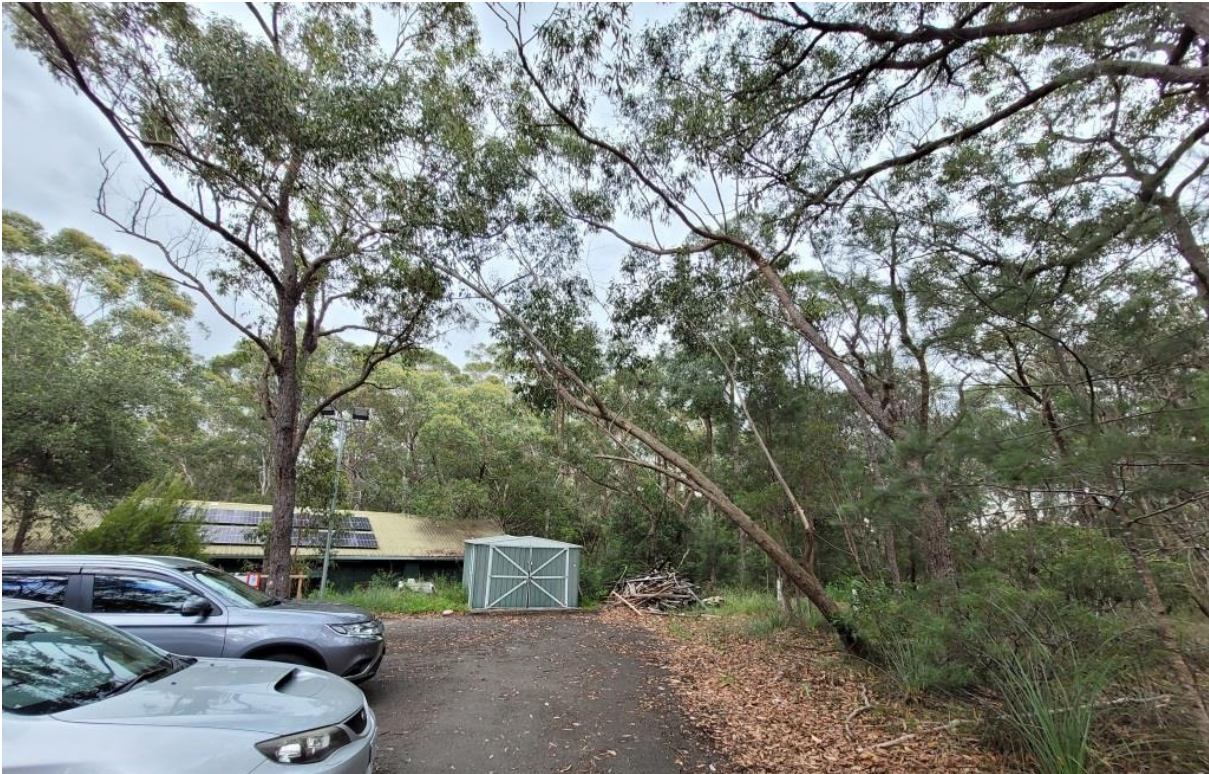
- 4.4.2 Tree T27 (Bloodwood) is to be retained. This tree is currently surrounded by asphalt. Refer to Figure 6 in **Appendix G**. The proposed carpark layout will enable the asphalt to be removed some distance from the base of the tree. The removal of the asphalt and installation of hardy ground covers and mulch will be beneficial to tree health. The asphalt will need to be saw cut then broken up and removed using appropriate handheld tools. Removal of all the asphalt is not required to benefit the tree. Mulch such as ripped sandstone may be suitable in this area as an alternative to bark mulch. Installation of bollards or barriers of rock should be installed to prevent vehicles from accessing the area and causing mechanical damage to the trees. Sections 6, 7, 8, 9, 10, 12 and 14 of the Tree Management Plan (**Appendix E**) are to be implemented to ensure that the impacts from demolition and installation of the nearby stormwater pit and pipes are minimised. The canopy of the tree is unaffected by the proposed development.

Figure 6 Tree 27 on the left and T27A with the severe lean on the right. T27 to be retained and protected and T27A removed.

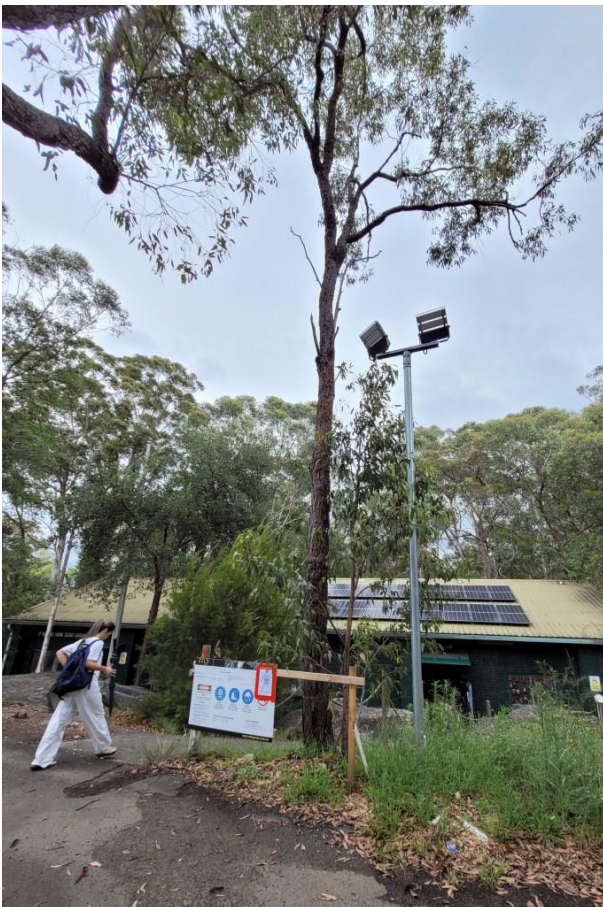
Figure 7 Tree 26 to be removed as it is located within APZ and close to the new proposed path, stormwater pipe and existing light.

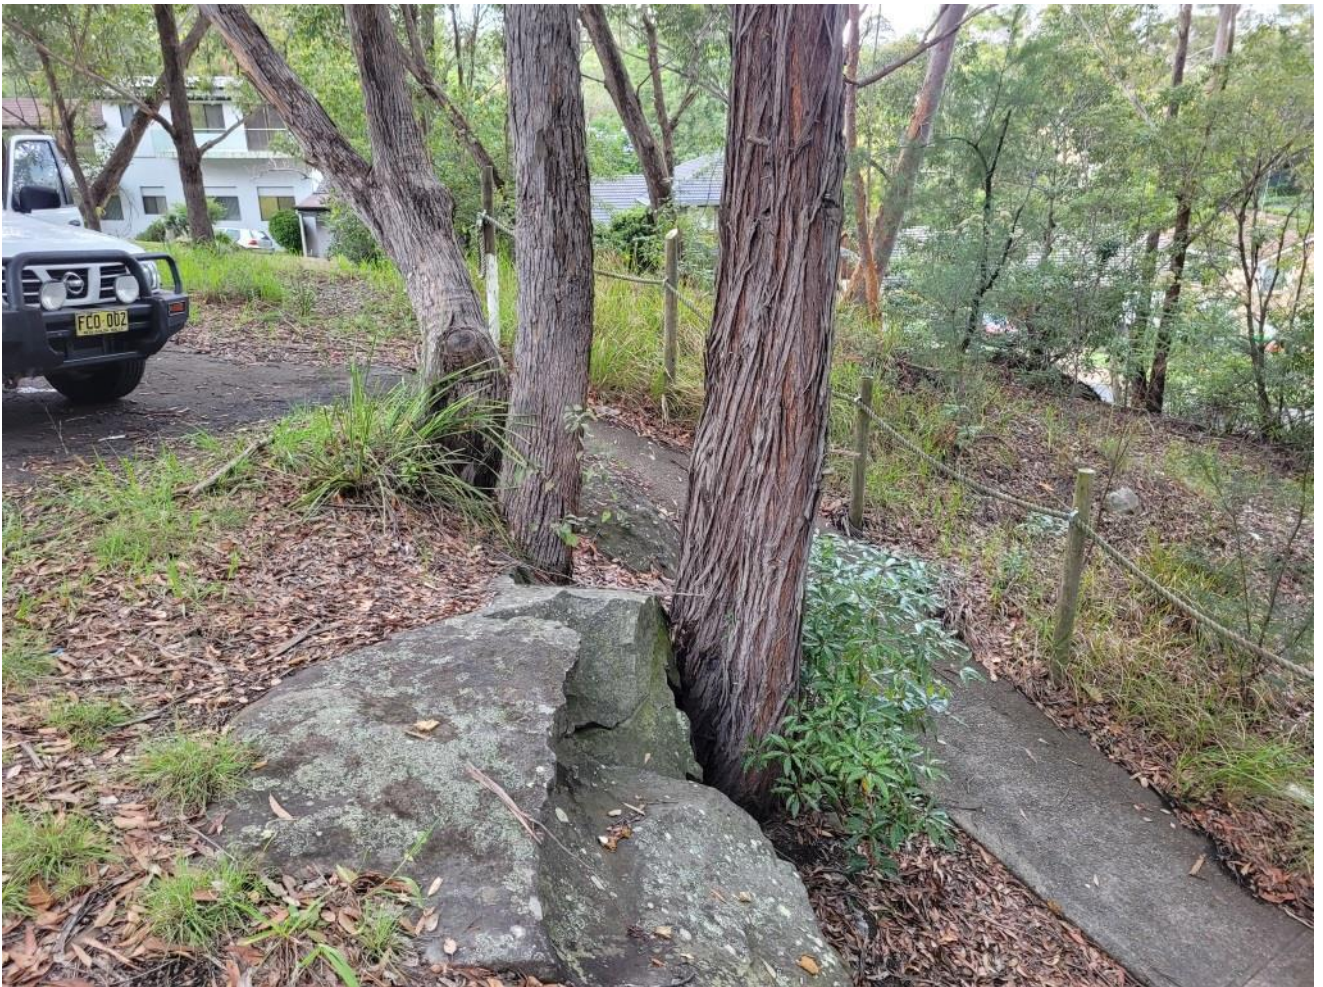
- T25 (Sydney Peppermint) is a group of two trees located adjacent to a steep entry path to the building within the APZ. Ideally only the two trees T25 would be retained and nearby group T24 removed to reduce the tree canopy close to the building. Refer to figure 8 in **Appendix G**. Further assessment may be required as the canopies of the groups of trees are intertwined and removal of one may leave the other exposed to adverse wind events that may result in branch failure. Further discussion with the client is required to ascertain the extent of community resistance to tree removal and the client's policy concerning asset protection.

Figure 8 Tree 24 in the foreground to be removed (group of 3 Turpentine) Tree 25 (2 x Sydney Peppermints to be retained). These trees are prominent as located in front of the hall. They are all located within the APZ.

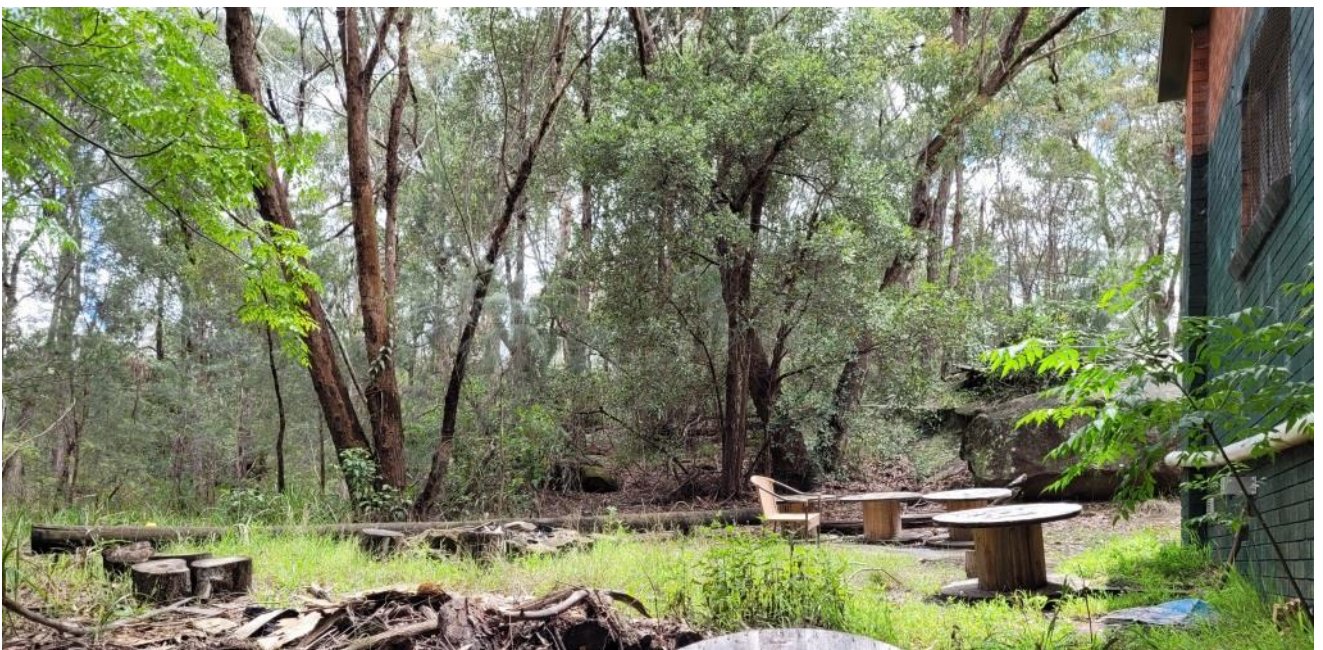
- T34 and T35 (Sydney peppermint) These trees are located on the adjoining allotment. Refer to Figure 9 in **Appendix G**. They are both located within the 10m APZ. The trees are located 9m and 7m away from the building respectively. Their canopies are a reasonable distance from the building and if required could be trimmed to maintain a 3m distance (minimum 2m is noted in the Bushfire Assessment report). These trees currently form a backdrop to the informal gathering area used by the Scouts for outdoor activities. These trees are located well away from the proposed works. If access beneath the canopy is required during construction the Site arborist is to be consulted to ascertain if ground protection, canopy protection and/or a tree protection fence is required during the works. Section 4 of the Tree Management Plan (**Appendix E**) is to be implemented if trimming of the canopy is required

Figure 9 Tree 34 and 34 are located within the APZ. Recommended for retention.

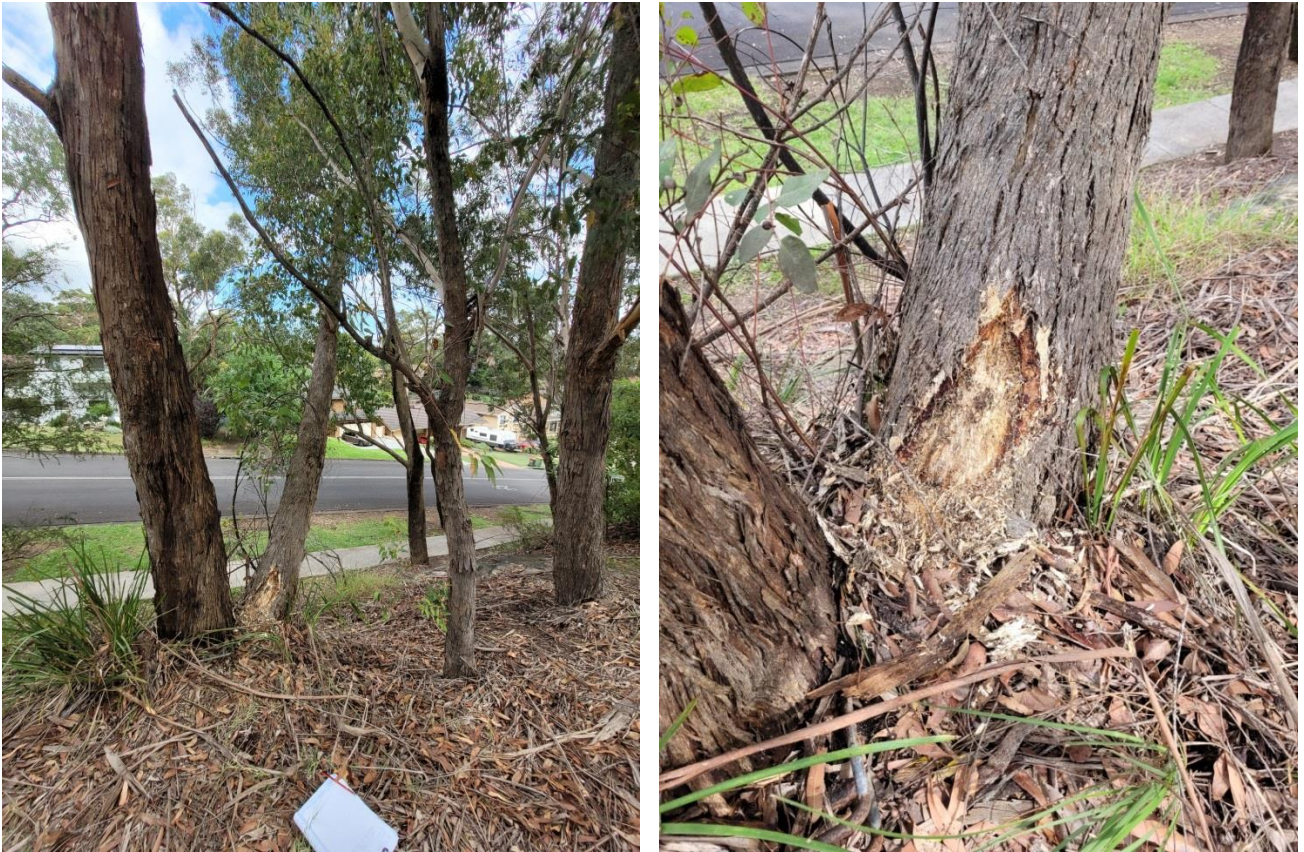
- T22 (Blackbutt) has a large dead branch that may need removal.
- T23 (Blackbutt) is a group of two. One of the trees in this group has a severe lean over the road and decay was evident at the base. The poor form of this tree and potential for failure will necessitate removal. Refer to figure 10 in **Appendix G**.

Figure 10 Tree 23 has basal decay in one trunk of a tree leaning over the road. Recommended for removal. Detail of the exposed area of decay can be seen to the right.

- T22 (Blackbutt) has a large dead branch that may need removal.
  - T23 (Blackbutt) is a group of two. One of the trees in this group has a severe lean over the road and basal decay. Removal is recommended.
