File Ref. No: BFS20/2836 (12863)  
TRIM Ref. No: D20/95076  
Contact: Qualified Firefighter Kristy Buckpitt

19 November 2020

**Re: INSPECTION REPORT  
MARINA SQUARE SEAFOOD  
SHOP 305A  
5 FOOTBRIDGE BOULEVARD WENTWORTH POINT (“the premises”)**

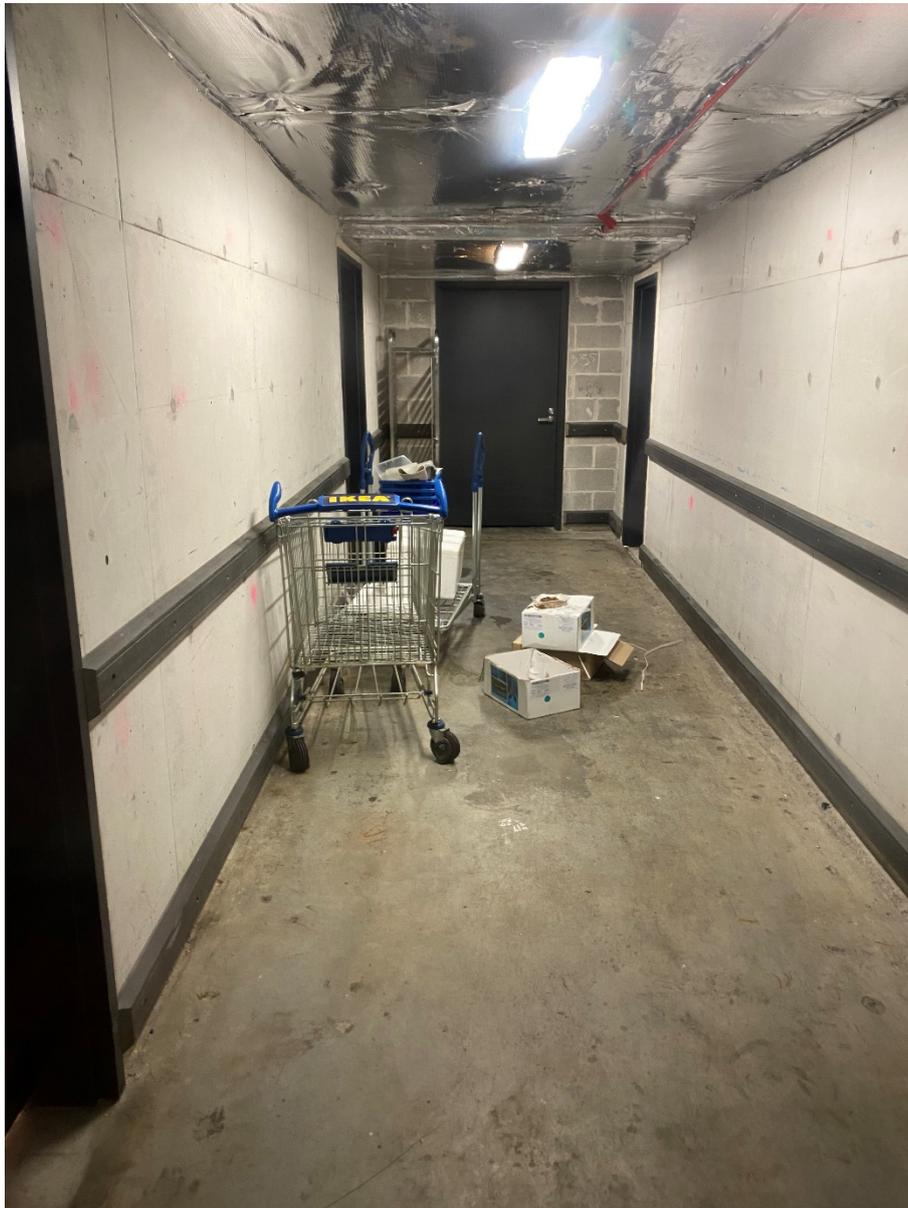
Appendix 1- Photograph of obstructions returned to the corridor

- A. The path of travel from the rear of shop 305a to the fire exit was obstructed by storage crates, shopping trolleys and store racks contrary to the requirements of Clause 186 of the Environmental Planning and Assessment Regulation 2000 (EP&A Reg).
  - i. FRNSW received photographic evidence on 27 October 2020 that the obstructions had been removed from the corridor.
  - ii. FRNSW received additional photographic evidence on 7 November 2020 that the obstructions have been returned to the corridor. Refer to Appendix 1.

- a. Inspect and address any other deficiencies identified on 'the premises', and require item no. 1 through to item no. 2 of this report be addressed appropriately.
