Arboricultural Impact Assessment

Proposed Child Care Centre (Drainage Works in Reserve)

73 Murray Farm Road, Carlingford, NSW

Prepared on – 07/11/22

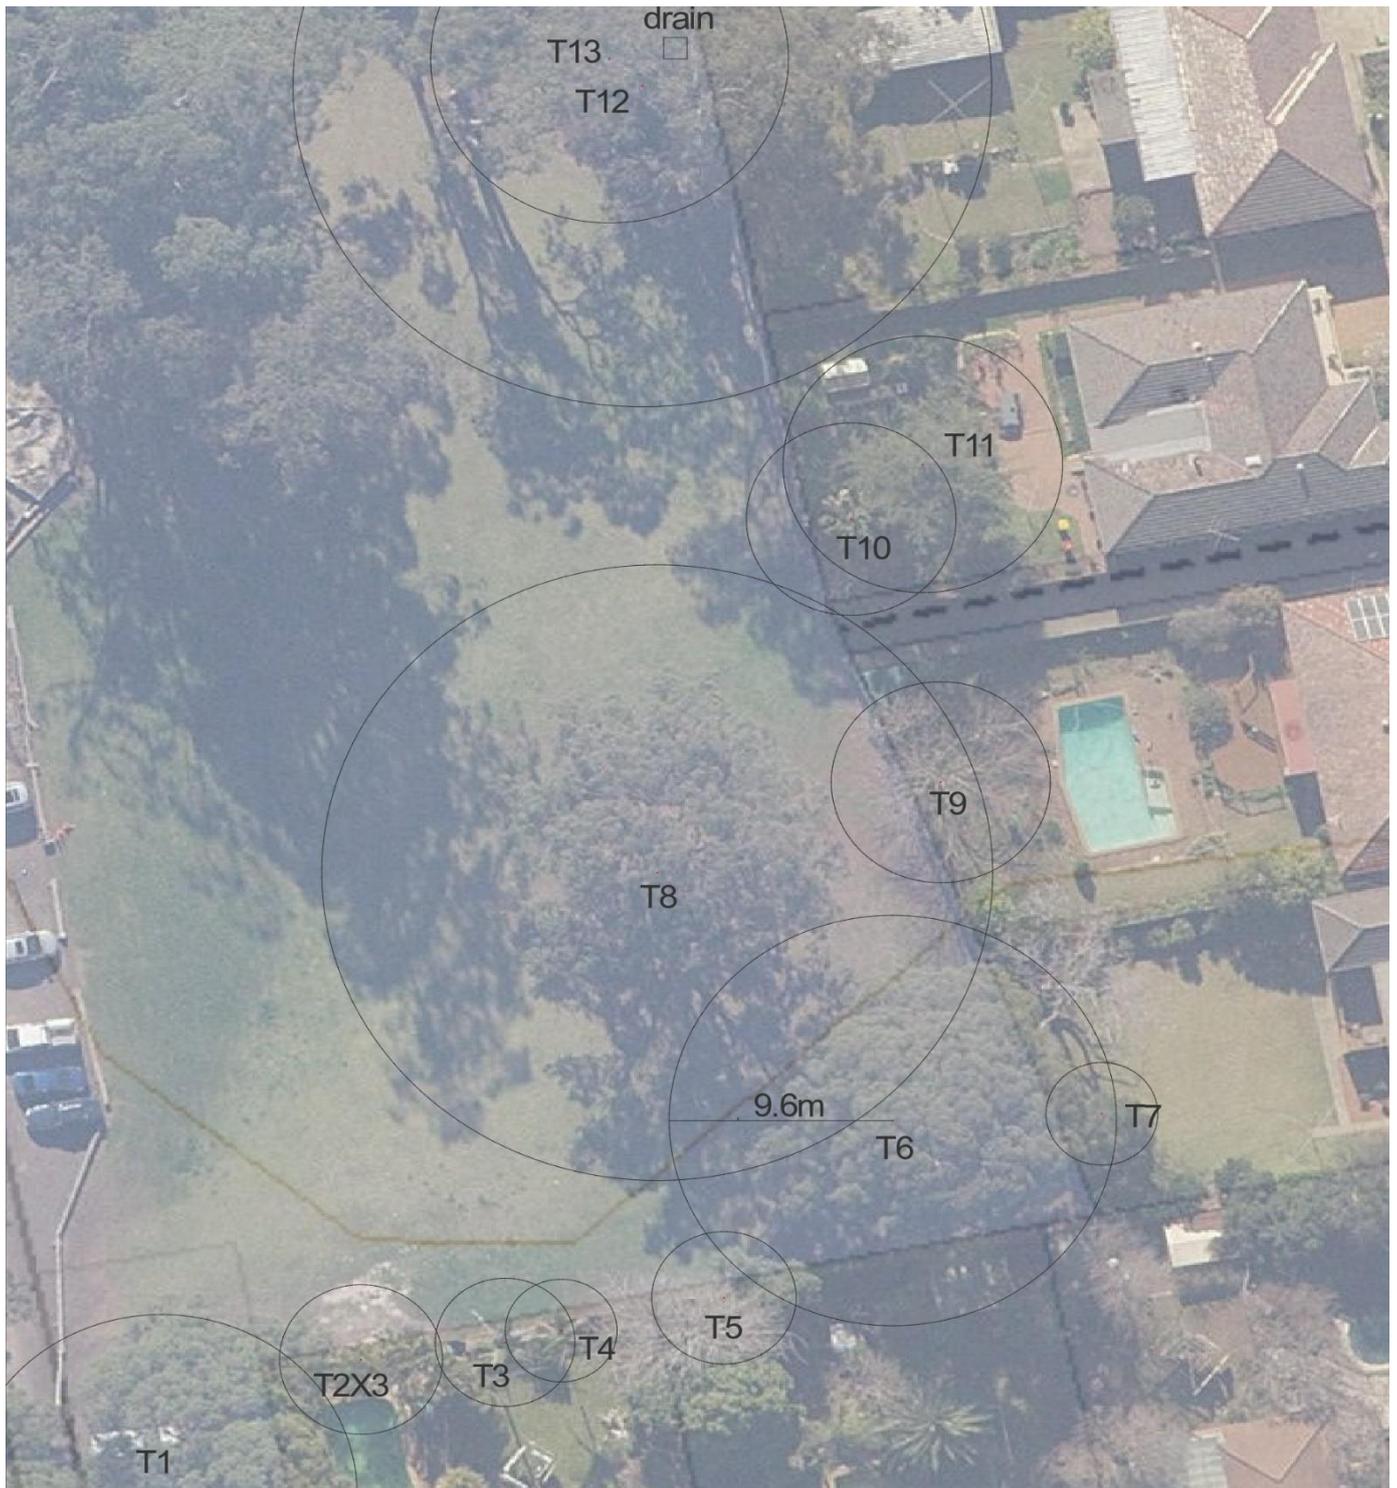
TREE LOCATION PLAN

Trees TPZ to ascertain Stormwater route

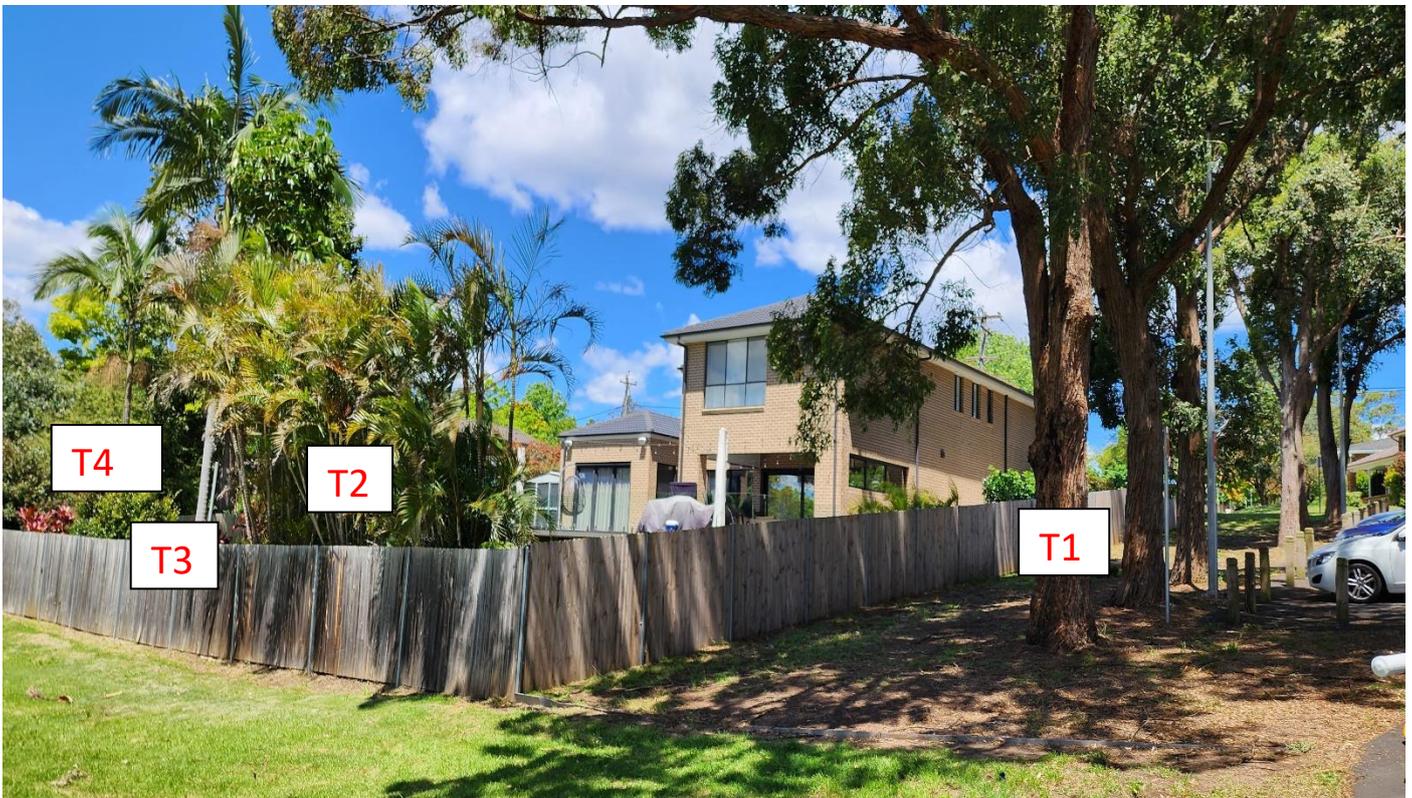
Tree 1) ***Eucalyptus microcorys*** - Tallowwood - Located within Councils Street verge fronting the Council reserve. This tree has a TPZ of 8.4m and is approx. 5.5m south of the edge corner of the adjacent backyards corner fence. If stormwater piping is to be excavated and installed, it is recommended to be conducted upon the northern edge of this trees TPZ, to minimise impacts to this tree.

Tree 2) ***Dypsis lutescens (x3)*** – Golden Cane Palm - Located within rear yard of No 69 Murray Farm Rd. This palm is a collection of clumps located close to the back fence of No 69. Being a palm and in accordance with AS4970 -2009, Section 3, 3.2, the TPZ should not be less than 1m outside the crown's projection. Therefore, these palms having a crown projection of approx. 2.5m in a northerly aspect, the TPZ has been calculated at 3.5m and the stormwater piping needs to be located upon the 3.5m TPZ projection, or further away.

Tree 3) ***Archontophoenix cunninghamiana*** – Bangalow Palm - Located within rear yard of No 69 Murray Farm Rd. Being a palm and in accordance with AS4970 - 2009, Section 3, 3.2, the TPZ should not be less than 1m outside the crown's projection. Therefore, this palm having a crown projection of approx. 2.5m in a northerly aspect and located approx. 1.5m away from the back fence, the TPZ has been calculated at 3.5m and the stormwater piping needs to be located upon the 3.5m TPZ projection, or further away.

Tree 4) ***Archontophoenix cunninghamiana*** – Bangalow Palm - Located within rear yard of No 69 Murray Farm Rd. Being a palm and in accordance with AS4970 -2009, Section 3, 3.2, the TPZ should not be less than 1m outside the crown's projection. Therefore, this palm having a crown projection of approx. 2.5m in a northerly aspect and located approx. 1.5m away from the back fence as well, the TPZ has been calculated at 3.5m and the stormwater piping needs to be located upon the 3.5m TPZ projection, or further away, into the reserve.

Photograph 1, above looking south east to trees 1, 2, 3 and 4.

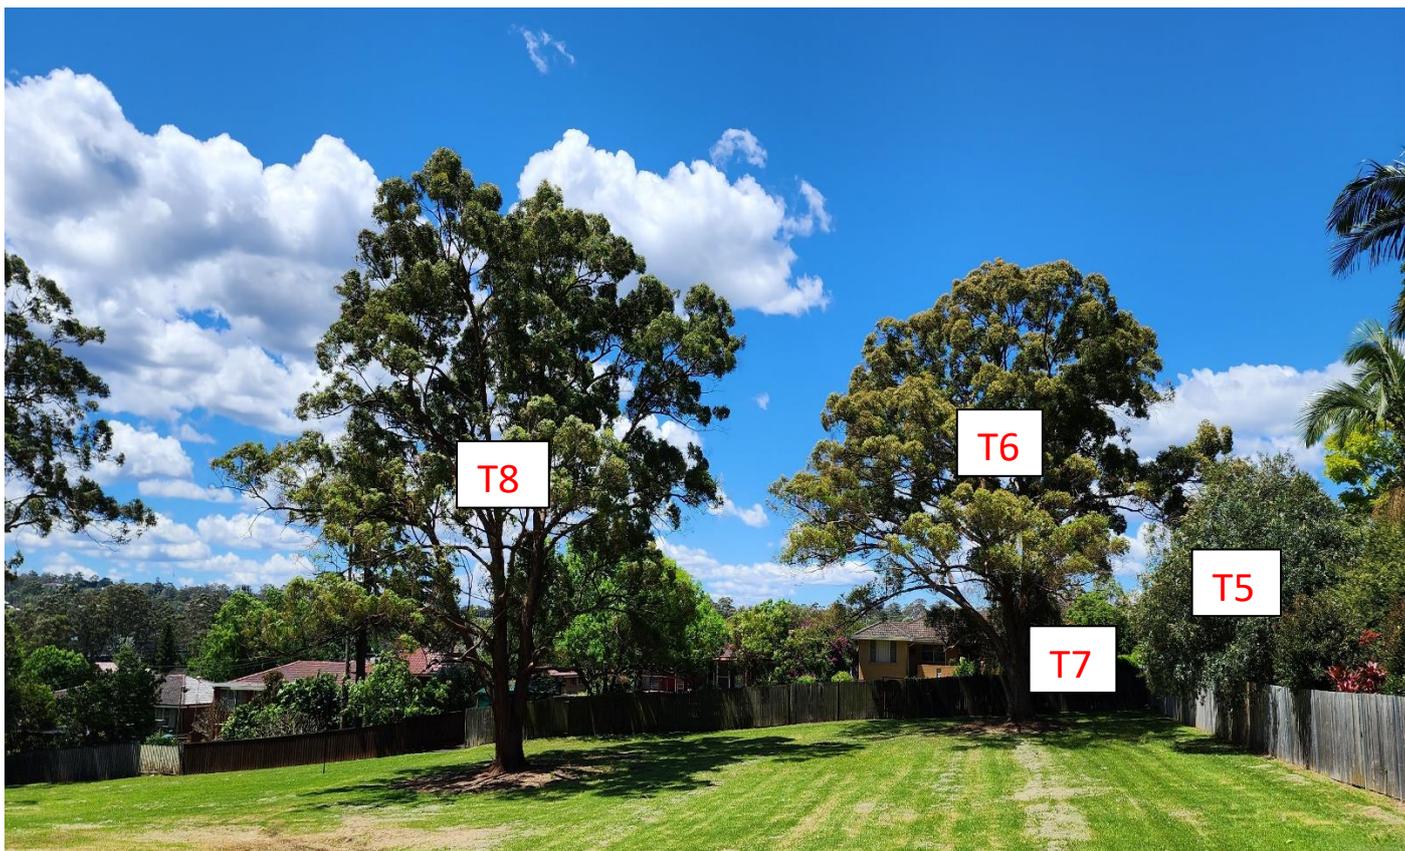
Tree 5) ***Olea europaea subsp. europaea*** - African Olive - Located within rear yard of No 67 Murray Farm Rd. This tree having a TPZ of 3.1m, the proposed piping could be located upon the outer edges of this trees TPZ, without impact this tree.

Tree 6) ***Eucalyptus microcorys*** - Tallowwood - Located within Councils reserve. This tree has a TPZ of 9.6m and encapsulates the entire corner of this reserve and therefore any excavations will

impact this trees southern, south eastern and eastern TPZ. It may be a better option to redirect the stormwater alignment prior to this trees TPZ and divert around Tree 8 to avoid this trees TPZ all together?.

Tree 7) ***Callistemon viminalis*** - Bottlebrush - Located within rear yard of No 4 Sylvia Ave. This small tree has a TPZ of 2.4m and stormwater piping could be located outside this trees TPZ, although that would impact tree 6s TPZ. These small trees western canopy extends approx. 1m over into the reserve with no impacts from machinery envisaged.

Tree 8) ***Eucalyptus microcorys*** - Tallowwood - Located within Councils Reserve. This large tree has a TPZ of 14.4m and extends well into adjacent neighbouring sites. If stormwater piping ran down the rear back fence of the neighbours, this would constitute as a major incursion to tree 8. A better option may be to redirect the stormwater alignment prior to this trees TPZ and divert around the western edge of this trees TPZ all together?

Photograph 2, above looking east to trees 5, 6, 7 and 8.

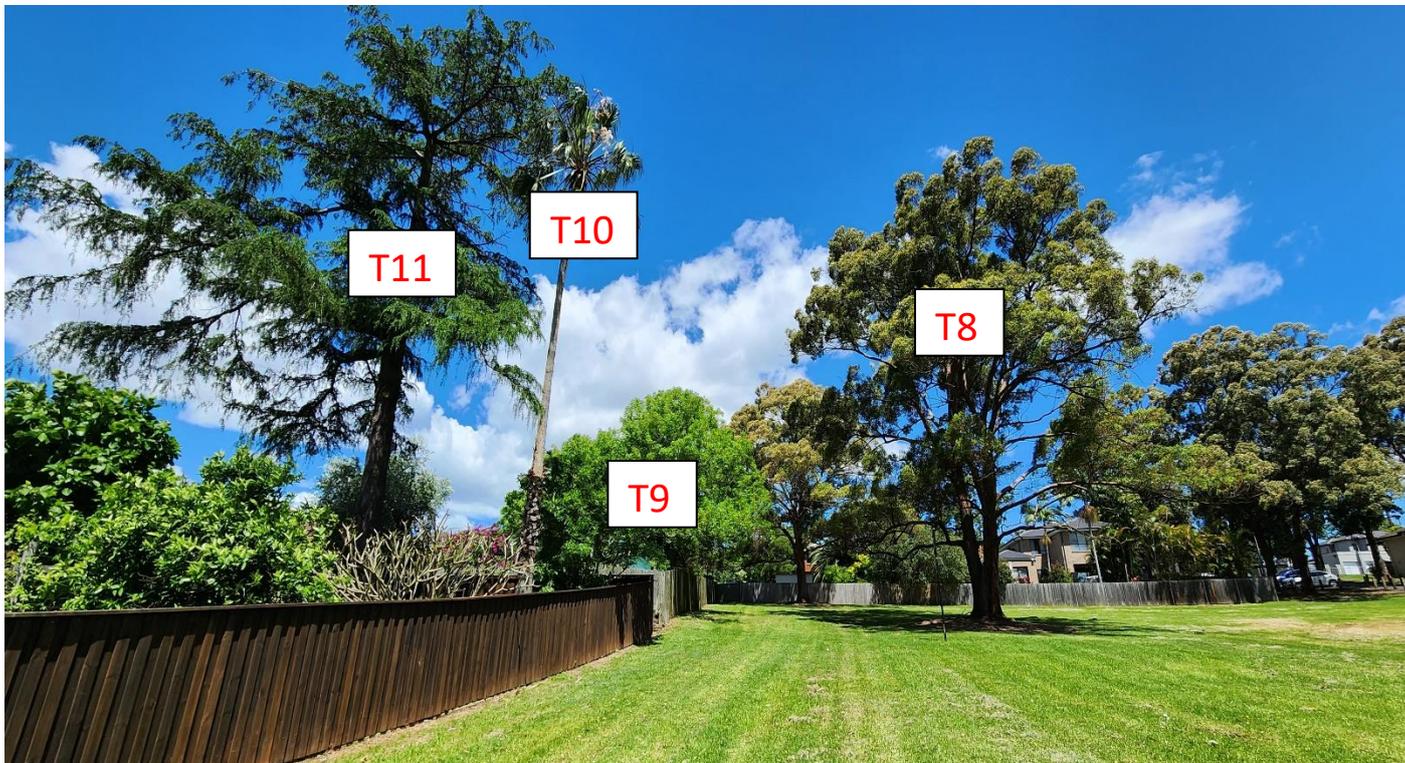
Tree 9) ***Fraxinus pennsylvanica**** – Green Ash - Located within No 6 Sylvia Ave rear yard. This tree has a TPZ of 4.7m radially out from its trunk and its TPZ cojoins with Tree 8. If stormwater piping ran down the back fence of this trees TPZ, it would constitute as a major incursion. A better option would be to divert the stormwater piping around T6 and 8s western TPZ and avoid conflicting with Tree 9 altogether.

Tree 10) ***Washingtonia robusta*** – Mexican Fan Palm - Located within No 8 Sylvia Ave rear yard. This palm has a calculated TPZ of 4.5m out from its trunk. This palm is approx. 1.7m in from the boundary fence and therefore its TPZ extends approx. 2.8m into the reserve. Stormwater piping could extend over to this palms TPZ and not closer than 3m from the boundary fence, to minimise impacts to this palms TPZ.

Tree 11) ***Cedrus deodora*** - Himalayan cedar - Located within No 8 Sylvia Ave rear yard. This tree has a TPZ of 6m and its outer western TPZ extends into the reserve by approx. 1 – 1.5m only and therefore, no impacts would be envisaged.

Photograph 3, above looking south to trees 8, 9, 10 and 11.

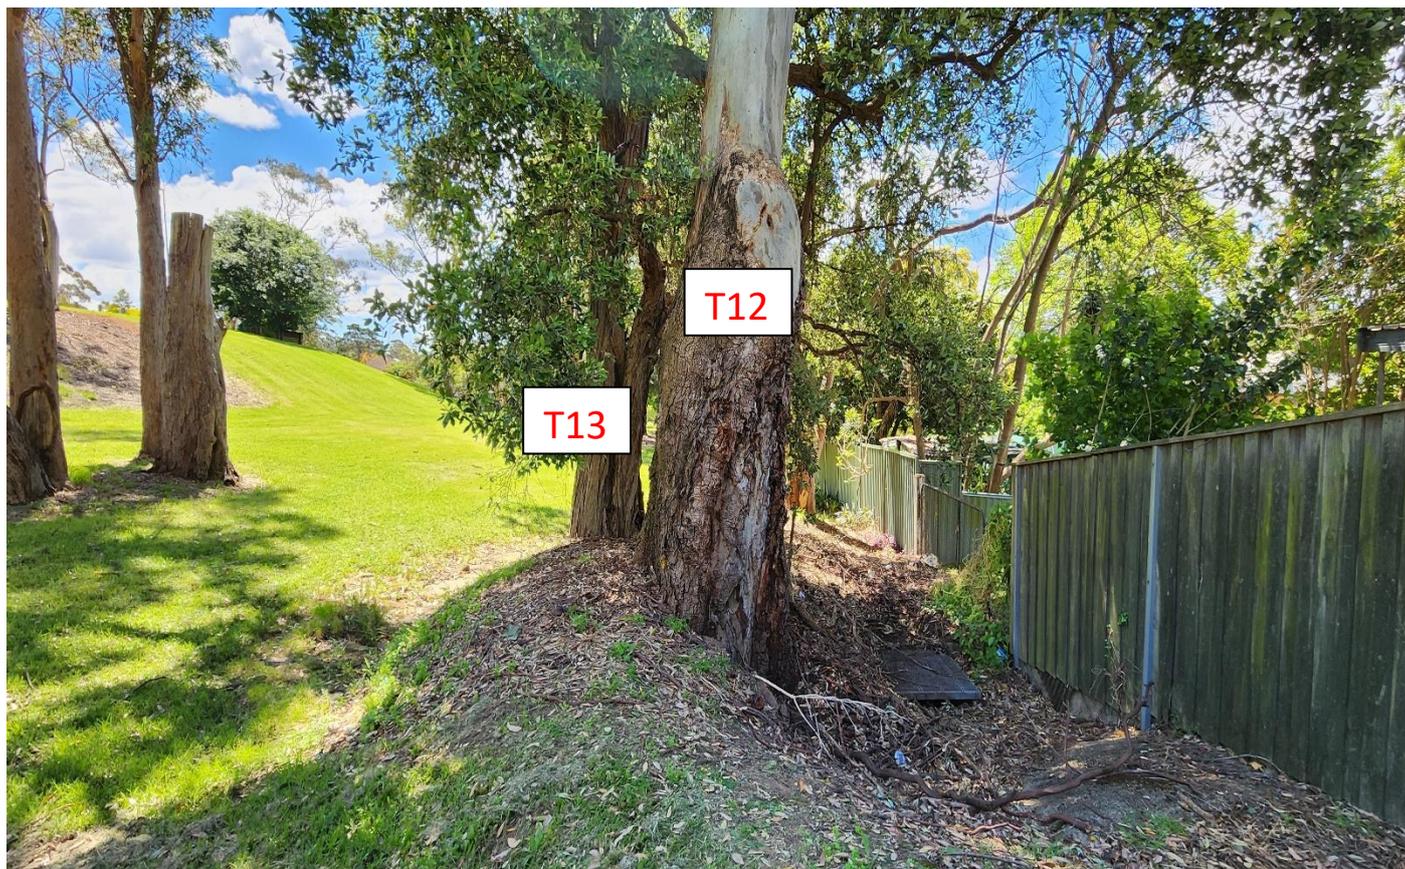
Tree 12) ***Eucalyptus saligna*** – Sydney Bluegum - Located within Councils Reserve, close to existing stormwater pit. This large tree has a TPZ of 15m radially out from its trunk, although the stormwater connection is proposed very close to this tree. Proposed excavations are recommended to be conducted using air spade, or hydro vac or underground boring to ensure minimal impacts to tree 12 are encountered. All works must be performed under the guidance and supervision of the AQF 5 Project arborist and signed off as compliant as per AS4970 - 2009.

Tree 13) ***Syncarpia glomulifera*** - Turpentine - Located within Councils Reserve, close to existing stormwater pit. This tree having a TPZ of 7.68m radially out from its trunk, although the stormwater connection is proposed very close to this tree. Proposed excavations are recommended to be conducted using air spade, or hydro vac or underground boring non-destructive excavation techniques to ensure minimal impacts to tree 13 are encountered. All works must be performed

under the guidance and supervision of the AQF 5 Project arborist and signed off as compliant as per AS4970 - 2009.

Photograph 4, above looking north to trees 12 and 13.

- Tree Protection measures, monitoring and Certification all in accordance with AS4970 – 2009, Section 4 and Section 5.
- Council should inspect the condition and structural integrity to tree 12, going forward.
- Tree Protection measures, monitoring and Certification all in accordance with AS4970 – 2009, Section 4 and Section 5.
- The implementation and signing off, of Hold Points and Certification table as per below 8.1 Hold Points & Certification.
