## FACADE RETENTION STRATEGY REPORT

# 197 Church Street, Parramatta

Ref: SY212658-  
Rev: A  
Date: 18.03.2022

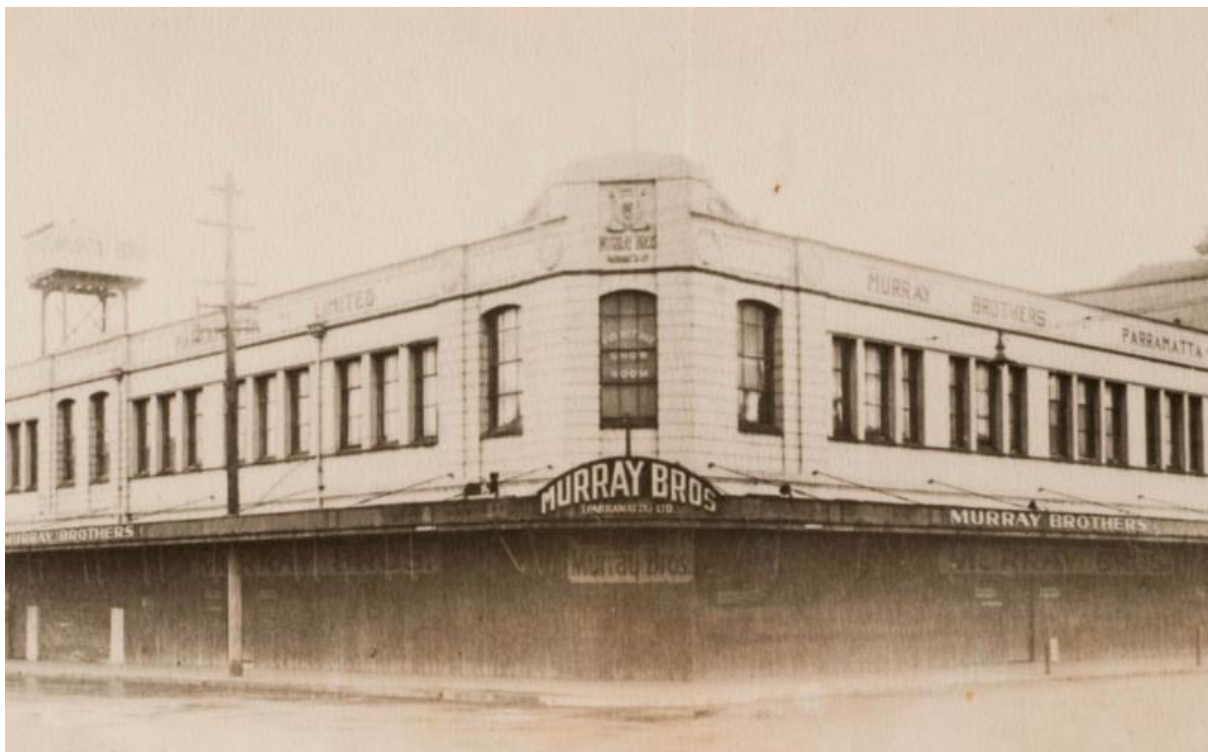
*Figure 1: Subject site and facade*

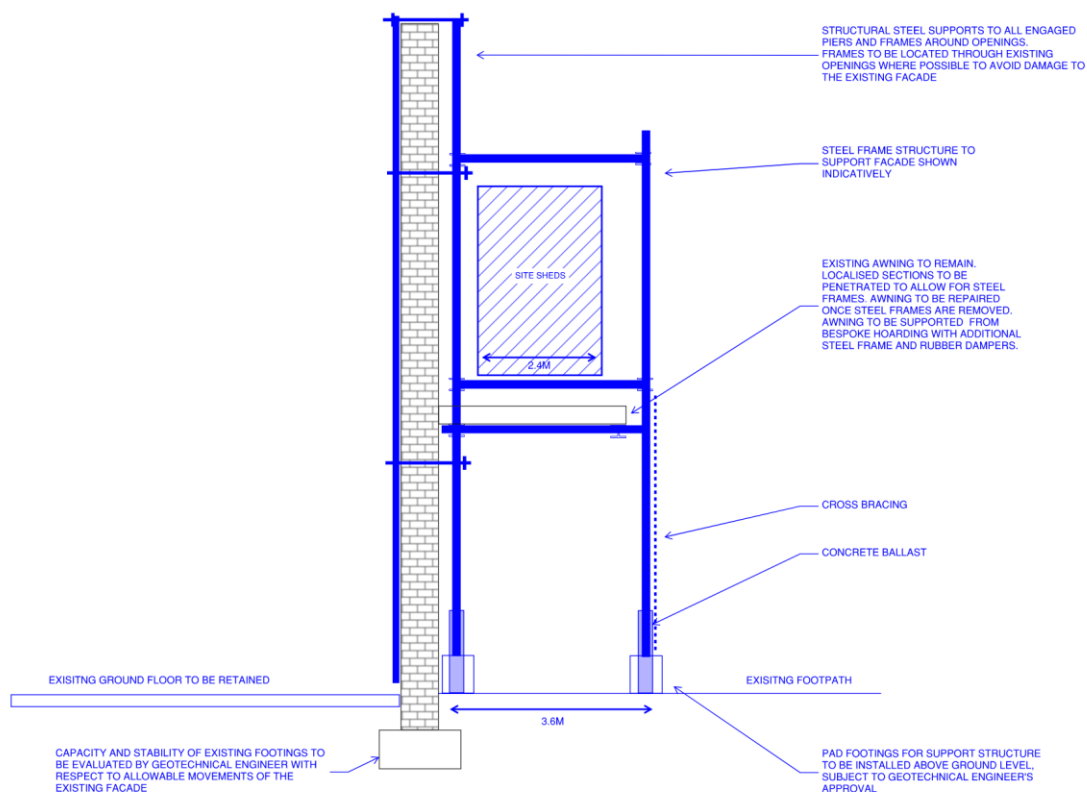
Figure 3: Section through heritage facade

A staged methodology as detailed below will ensure that the façade is protected throughout construction and effectively retained as part of the new development. Refer to Figure 3 for a sketch showing each of the following stages.

2. A specifically designed Class B hoarding with extended braced columns is then to be constructed adjacent the heritage façade. The proposed extent of this hoarding is shown in Figure 2. The design of these frames is to be such that the heritage wall can be positively restrained at all window and door opening points, and parapets. The frames must also avoid any decorative elements as nominated by the heritage consultant. Refer Figure 3 for section.

4. Once the façade and awning are deemed remediated and stable by a qualified and suitably experienced structural engineer, then the existing building can be carefully disconnected to the façade and removed.
5. Shoring works can commence once the site is cleaned up, and the nature of the existing footings under the heritage façade investigated and remediated if necessary. Refer Figure 3

6. As excavation is carried out, temporary steel struts must be installed between shoring walls to limit their movement. Refer Figure 3 (6) for indicative locations of struts. Monitoring of the façade must occur during the shoring and excavation process, with defined hold points for vibration and movement developed with the geotechnical and structural engineers.
7. The new building can now be constructed using conventional building techniques, designed to support the existing façade in the permanent condition with a new concrete-framed structure. New steel framing will be used to support the parapets, bolted to the concrete slabs. This framing will need to be pinned through the existing façade in locations to be approved by the heritage consultant. When this structure reaches strength, the hoarding can be safely removed.
