# STATEMENT OF HERITAGE IMPACT

## Proposed Demolition at 197 Church Street, Parramatta

Job No. 9219  
August 2021

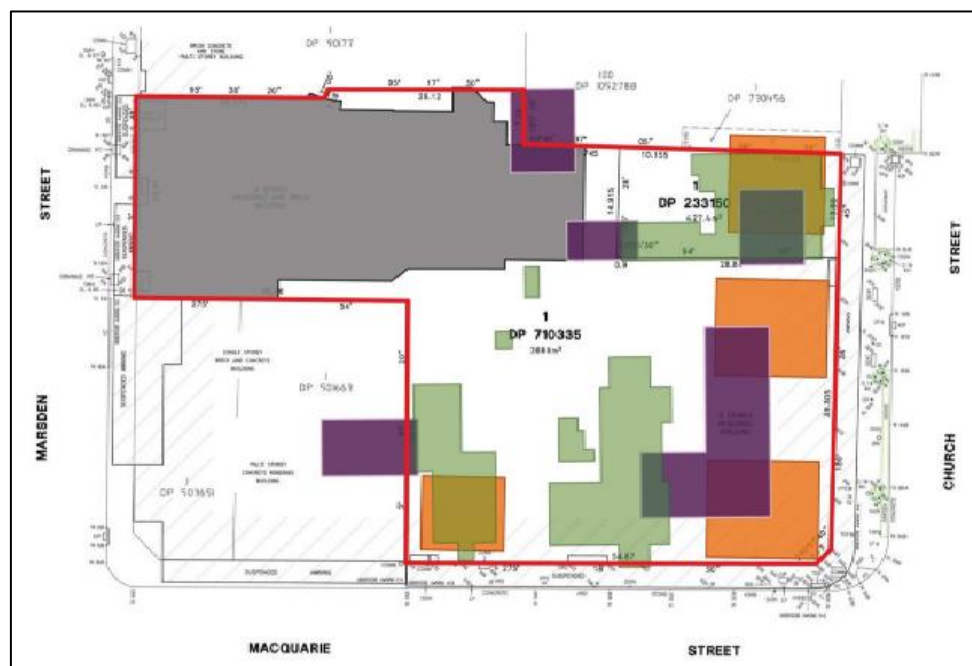
Figure 14. Locations of buildings associated with historical phases. Key: Orange: phase 1. Purple: phase 2. Green: phase 3. Grey: no archaeological potential. (Source: GML report).

Buildings associated with these historical phases may be represented as in Figure 14.

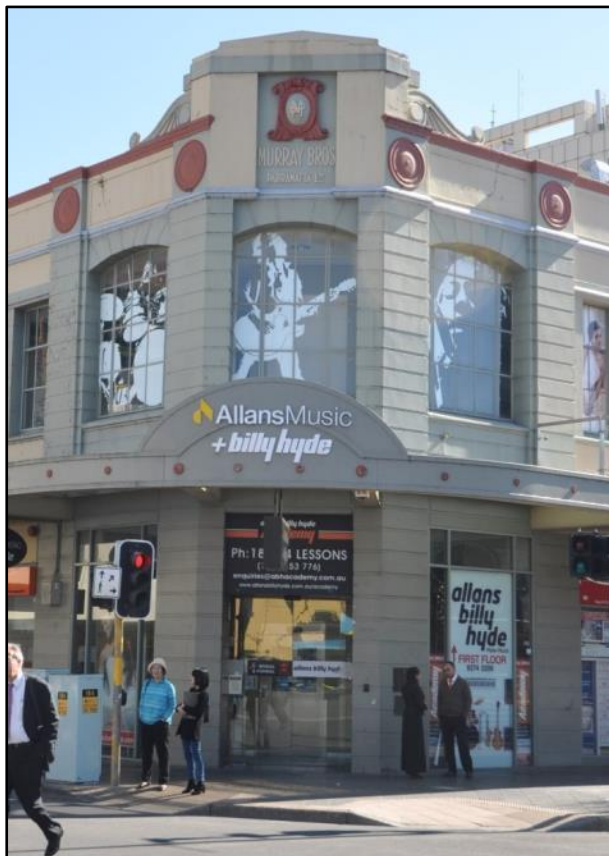
- The elevations show a proposed new glazed balustrade and new balcony and balustrade. Demolition of the original awnings was proposed. Although the awnings existing today has pressed metal undersides, based on historic and current photographs it does appear to have been raised and the structure altered (tie rods no longer visible).
- All three windows near the corner are altered with a new pre-cast arch and removal of brickwork to create wider windows (see photo at left with five panes of glass across – formerly three).
- A new glazed awning is proposed at the corner (present today)
- Lintels and brickwork above the ground floor corner window are removed. New steel framed glazing is added (see photo at left).

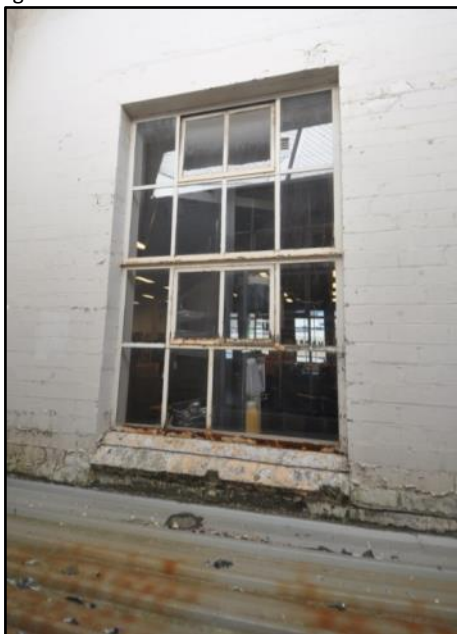
Figure 52: Detail of steel windows to light well showing hopper style openings and corrosion.

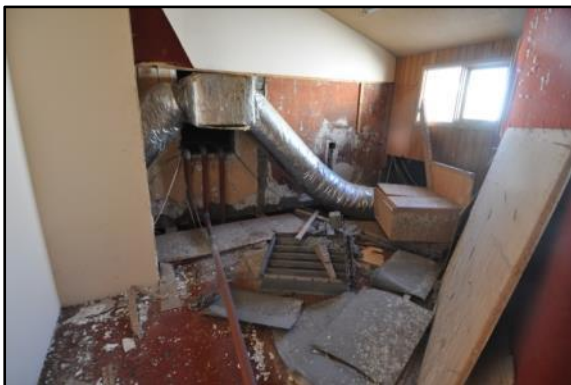
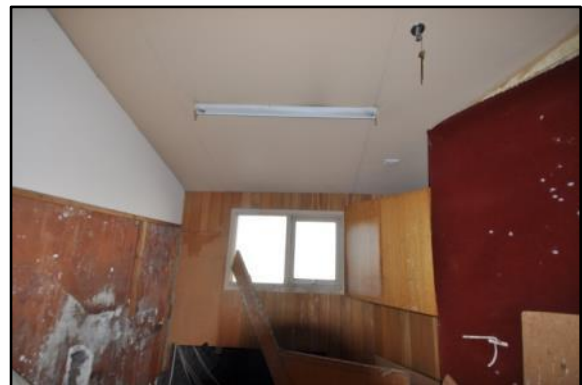
Figures 57 & 58: South-east corner. Services have been inserted into the space. Linings are not original and are peeling away. Most surfaces in poor condition and damaged.

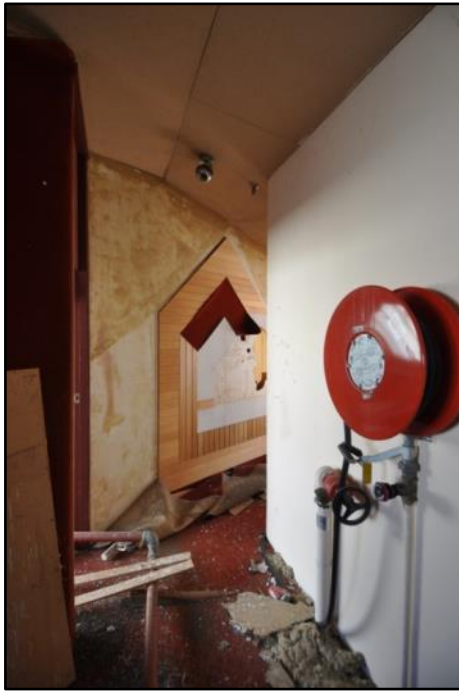
Figures 59 & 60: Central corridor. Linings are not original and are peeling away. Most surfaces in poor condition and damaged.

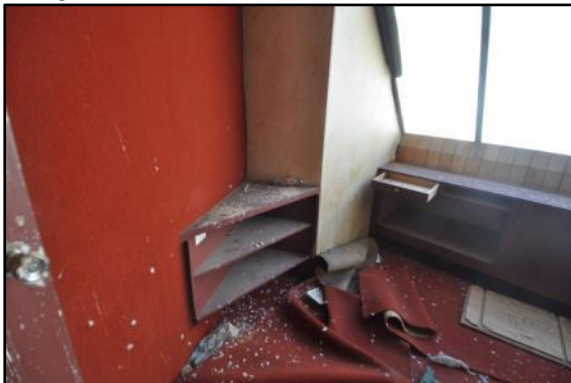
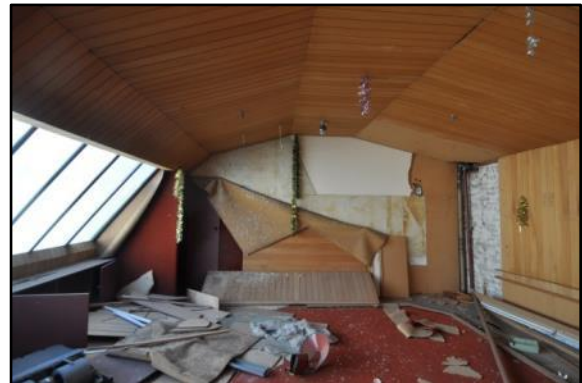
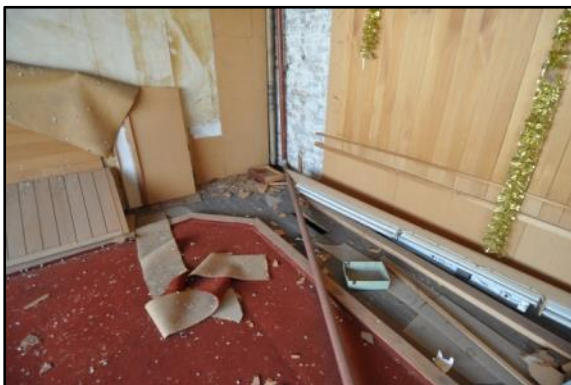
Figures 61, 62, 63 & 64: Main room on south side. Linings are not original and are peeling away. Most surfaces in poor condition and damaged. Timber flooring and masonry wall visible.

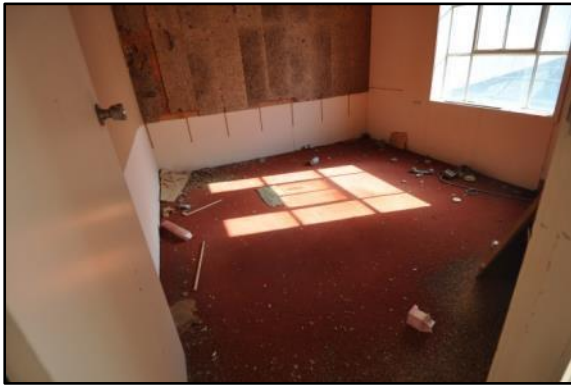
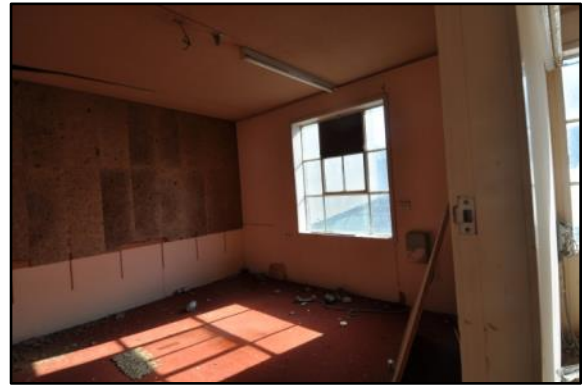
Figures 65 & 66: Interior of room at north-west corner. Linings are not original and are peeling away. Most surfaces in poor condition and damaged.

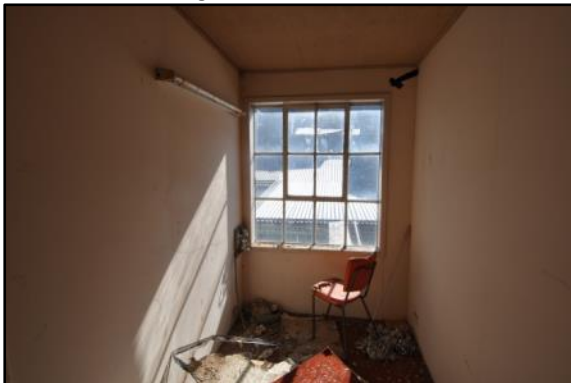
Figures 67 & 68: Room on north (left) and corridor where former staircase was. Linings are not original and are peeling away. Most surfaces in poor condition and damaged. Services have been inserted into the space.

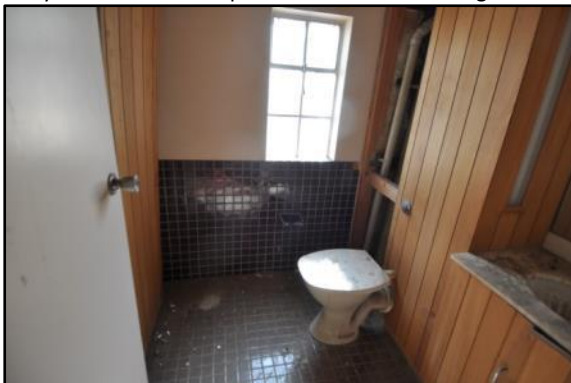
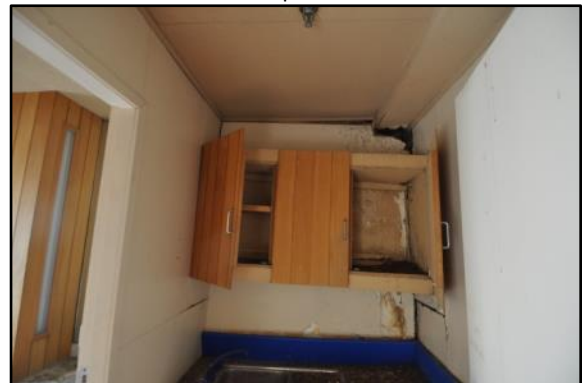
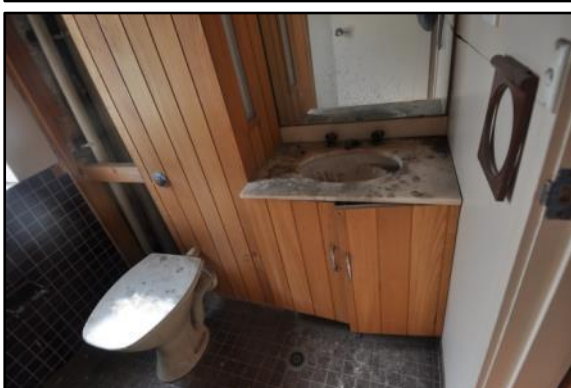
Figures 69, 70, 71 & 72: Kitchenette/bathroom areas at north-east corner. Fixtures and finishes are not original. Most surfaces in poor condition and damaged. Timber flooring and masonry wall visible.
