ARBORICULTURAL IMPACT ASSESSMENT

DBG

1 Tracey Ave,
CARLINGFORD NSW 2118

Report Reference: AIA – DBG 07/23 Rev B.
5th July, 2023

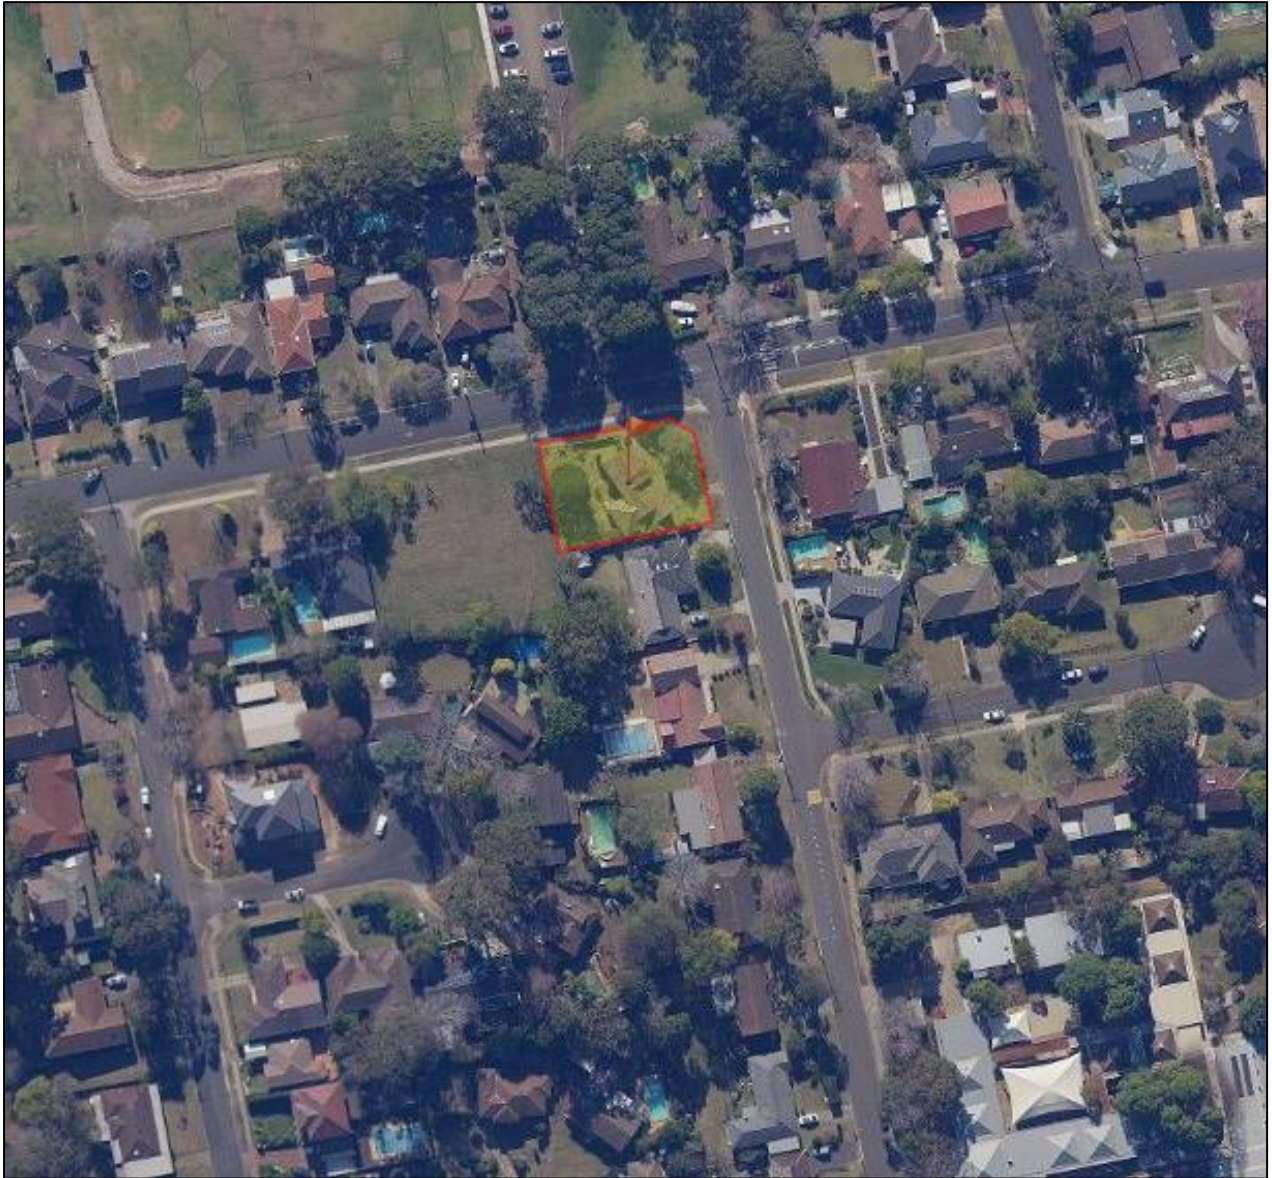
Figure 2: SixMaps aerial imagery

- VI. Site vegetation appears to be introduced or self seeded trees and shrubs from past landscapes.
- VII. See picture (below) ,courtesy of SIXMaps, with sites highlighted.

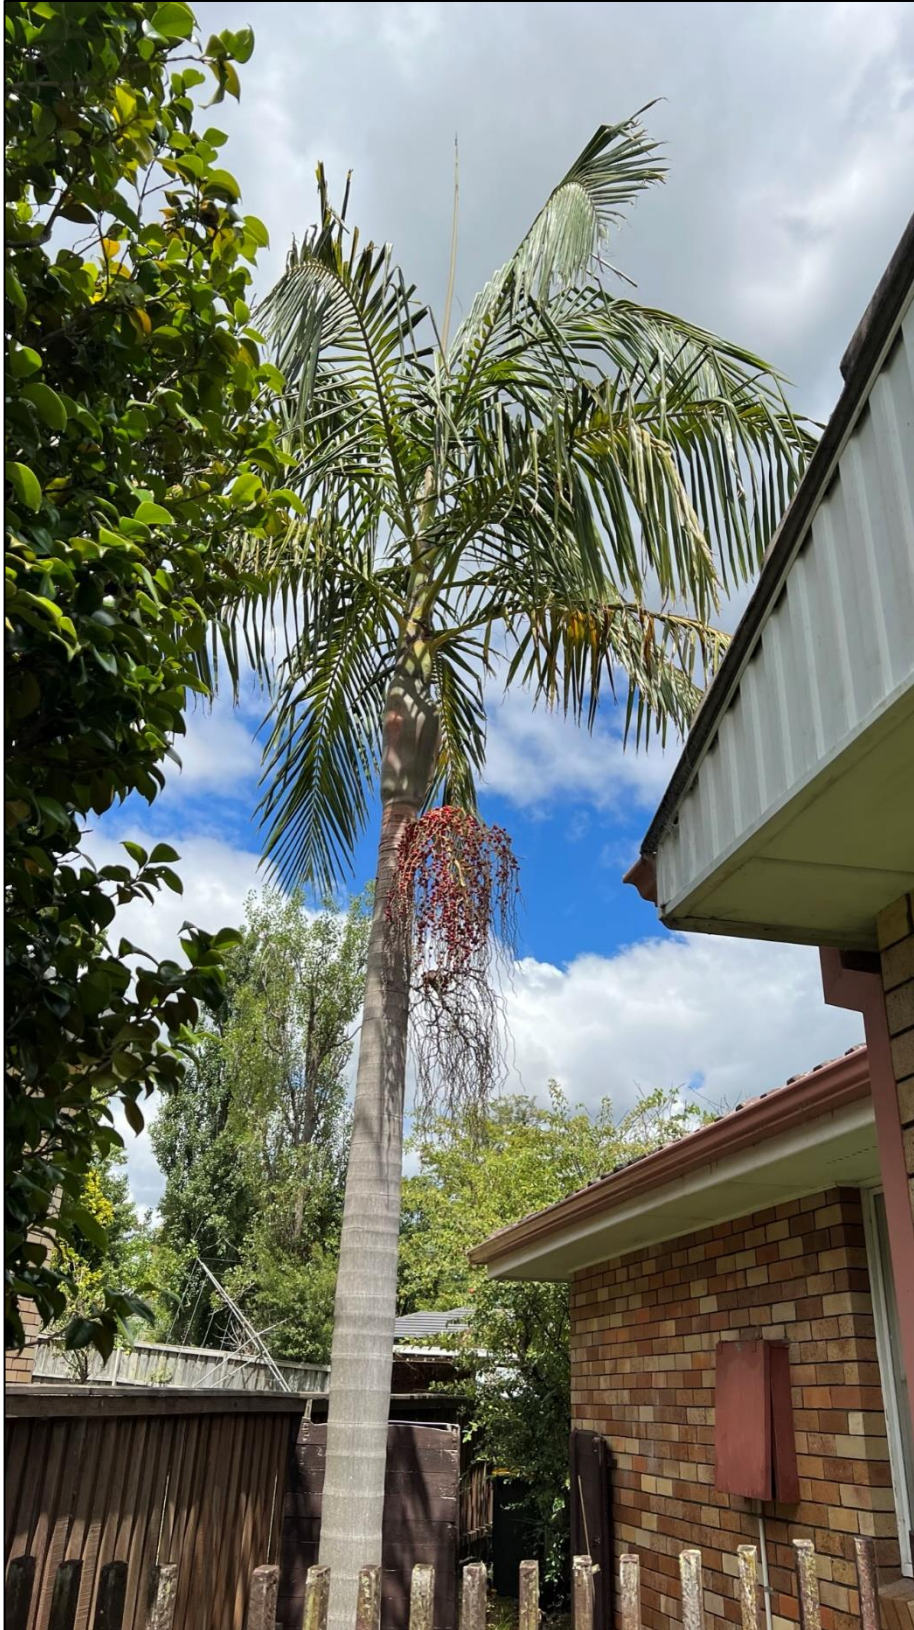
Photograph 2: T2, Bangalow Palm

- III. For T2, it is either inappropriately planted or indeed self-seeded, and given that it is within 5m of the existing dwelling, is exempt.
- IV. For trees 3, 4 and 6, the Arborist notes that they are marginally higher than the prescribed height, are ornamental trees, and not of high significance.

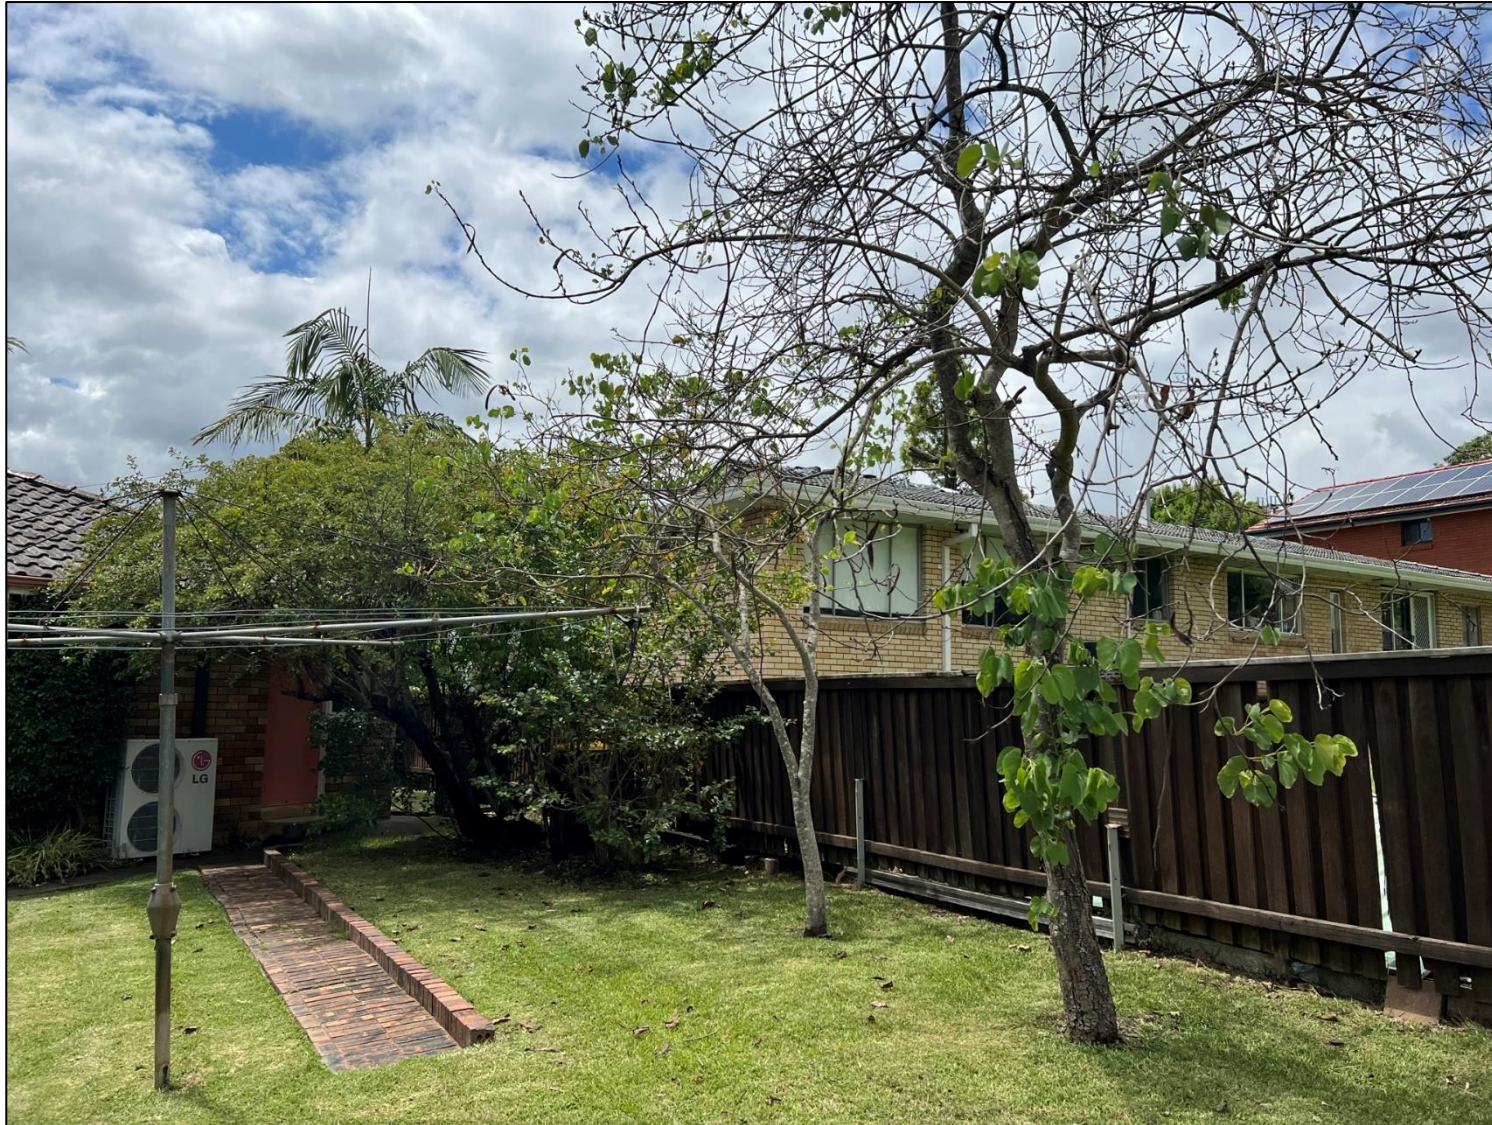
Photograph 3: T3, Bauhinia and noting smaller vegetation in background.

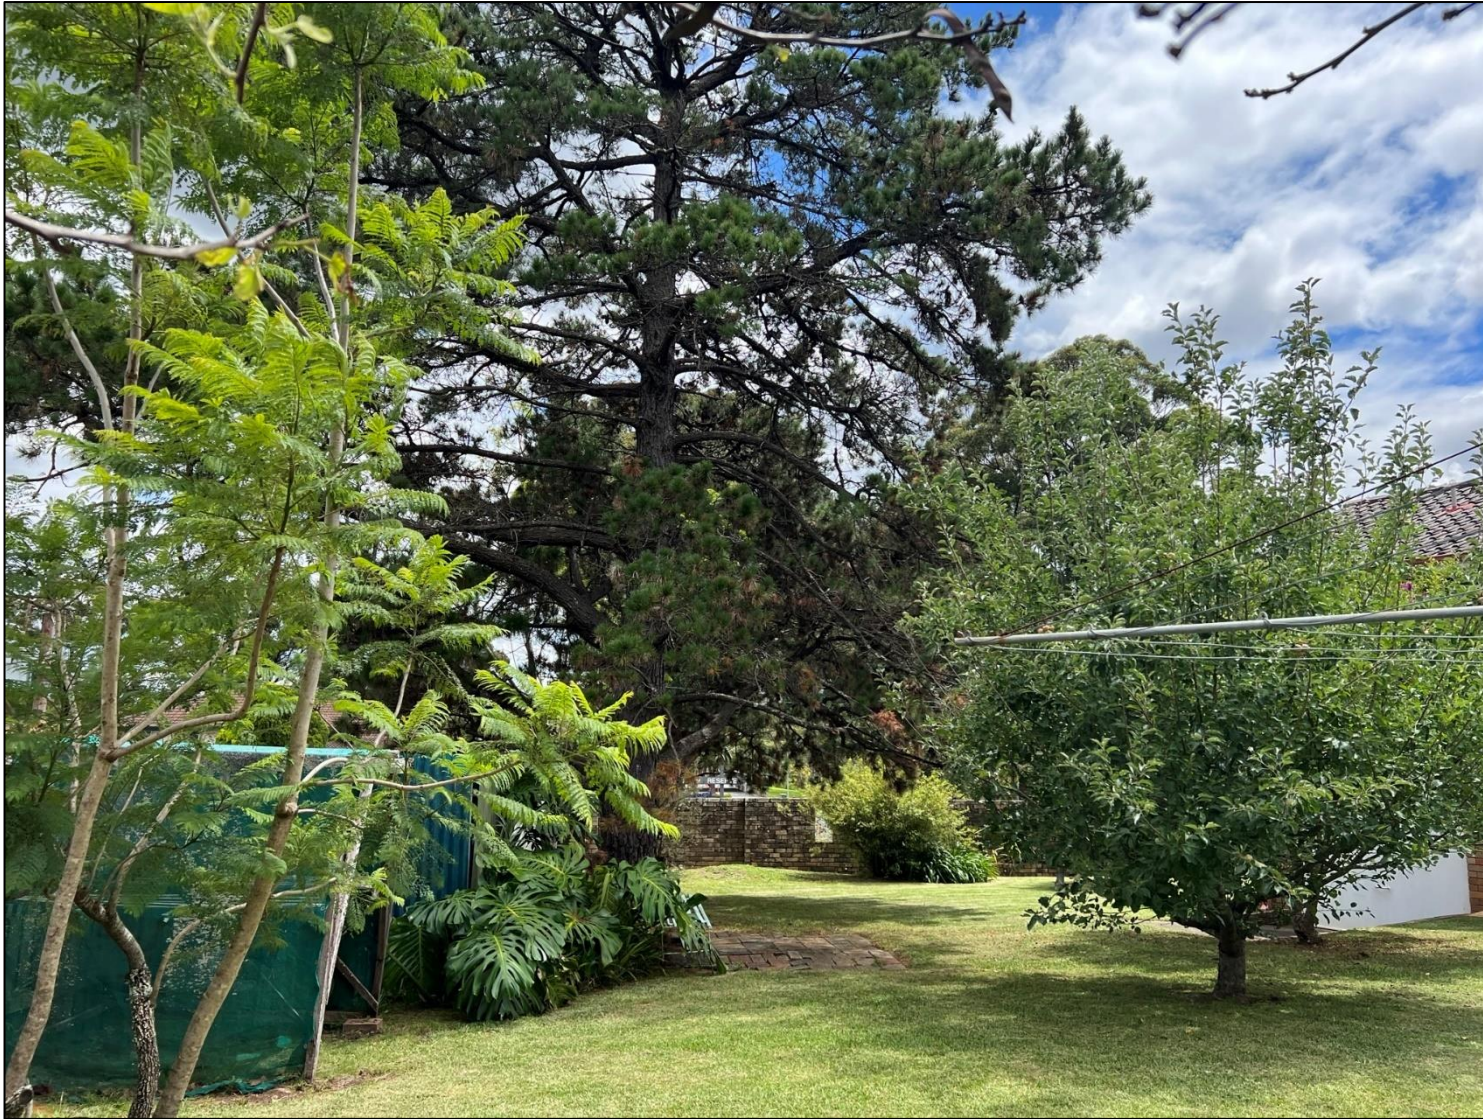
Photograph 4: Foreground, T4, and T5 in the background.

- VI. In this case, the inclusion of basement parking, to meet the needs of increased patronage, requires more developable area, with major soil cuts, inevitably at the expense of the natural environment, where essentially all trees are consumed, *wholly*, or to a major degree, such as for T4.

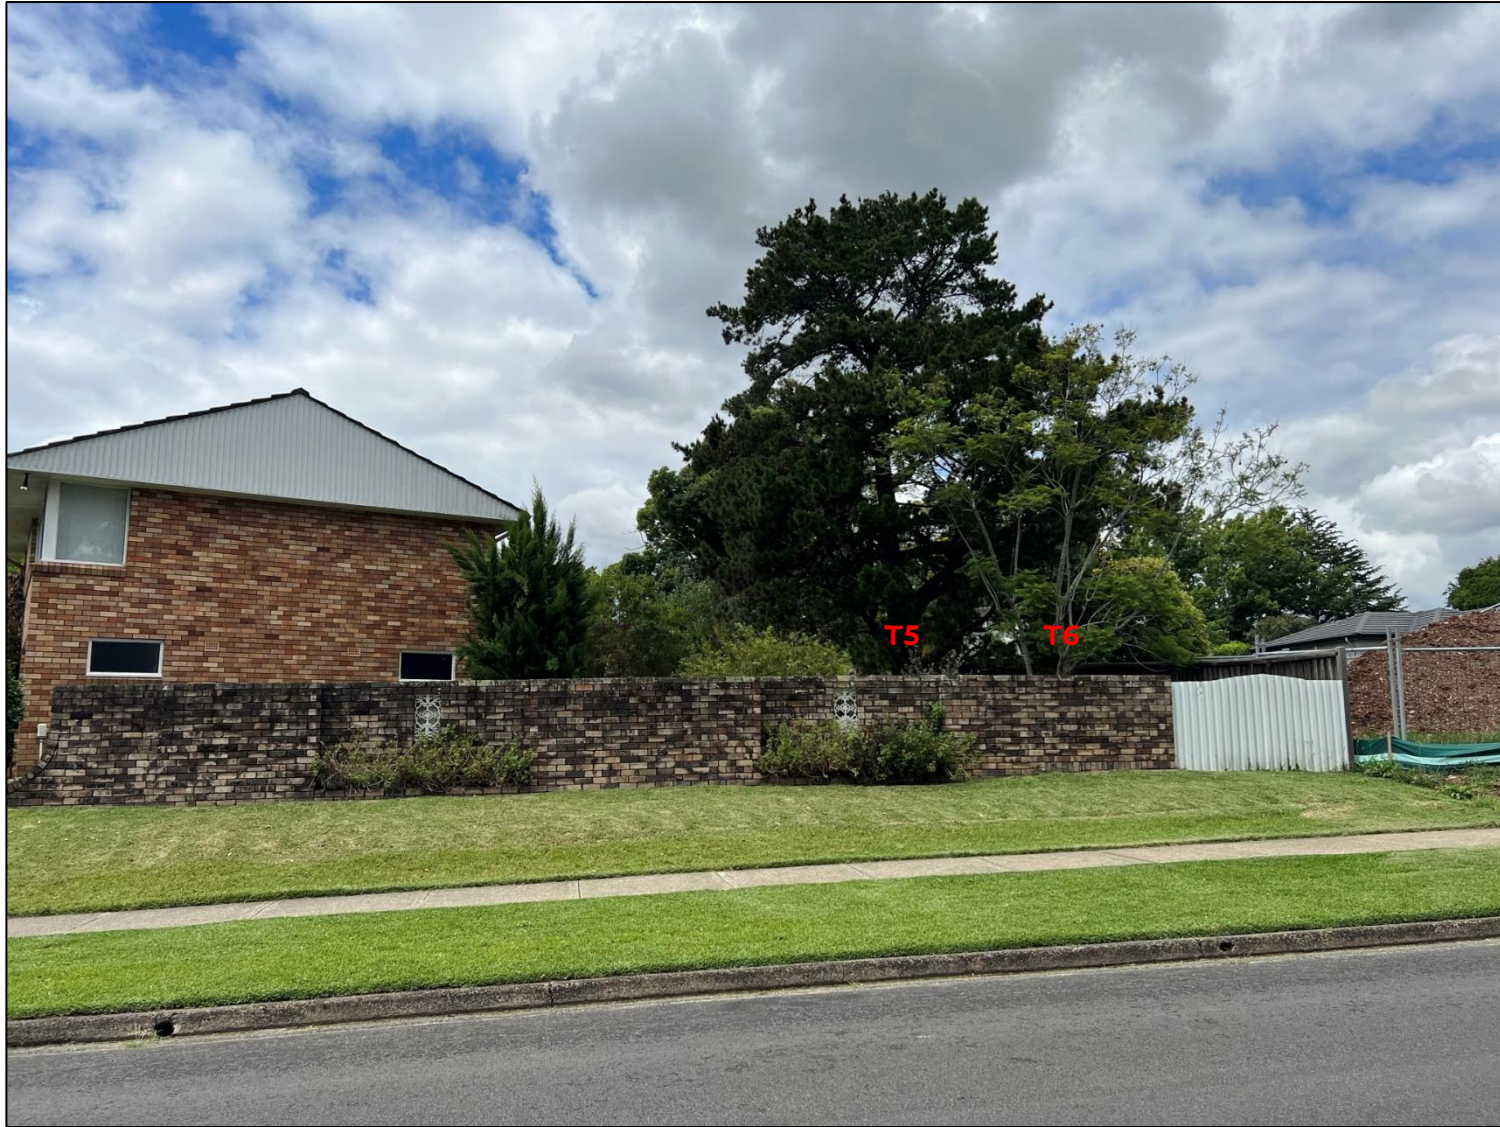
Photograph 5: Taken from Murray Farm Rd, with T5 , and T6

- V. The Arborist recommends that all site trees, T1-T6, be removed to facilitate the construction of the child care centre. Tree removal shall be undertaken in accordance with Code of Practice , Amenity Tree Industry 1998, Workcover NSW.

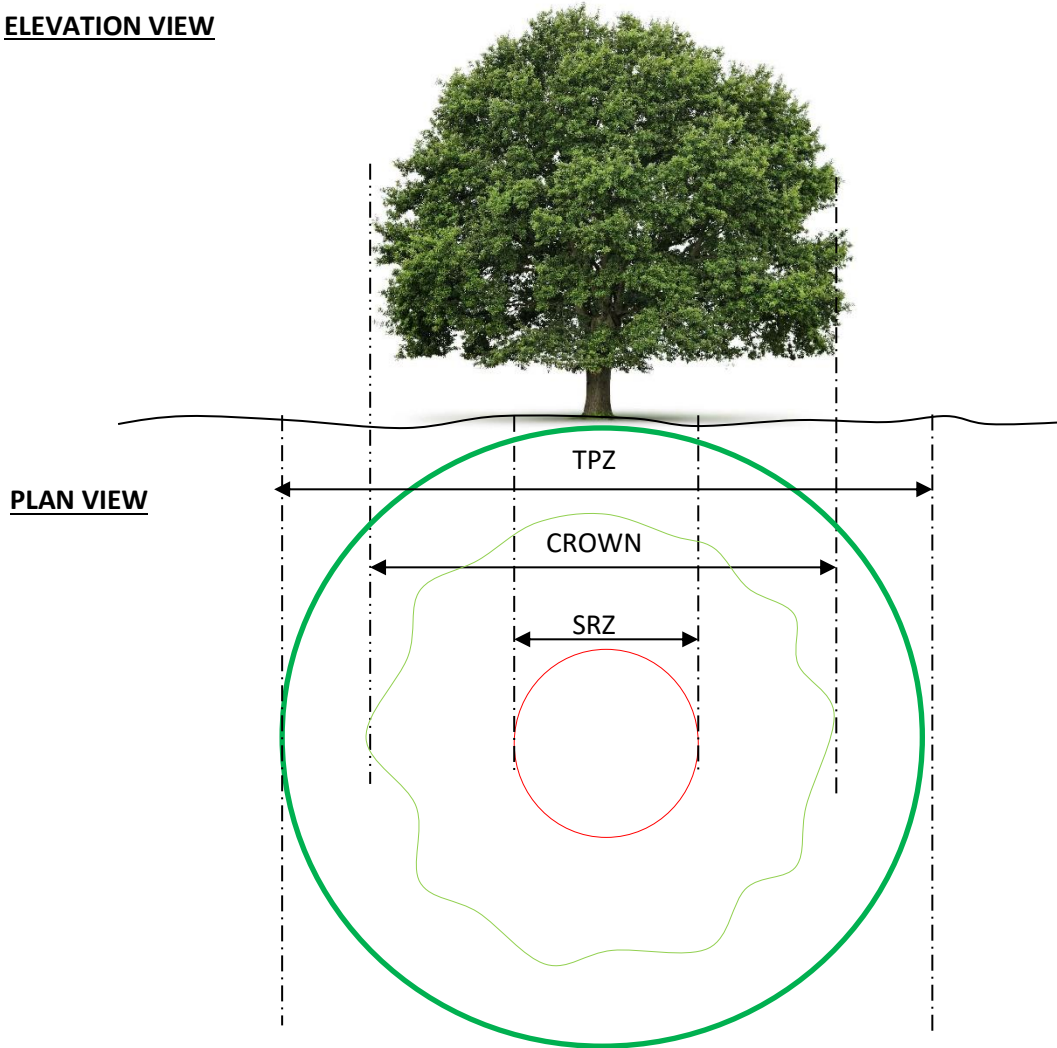
Indicative TPZ and SRZ (AS 4970/2009)

$$\text{TPZ (Radius)} = \text{DBH} \times 12$$

$$\text{SRZ (Radius)} = (D \times 50)^{0.42} \times 0.64$$

- The Australian Standards provides a formula for calculating both the TPZ and SRZ. The TPZ is a combination of both root and crown area requiring protection for viable tree retention. Basically, it is the area isolated from construction disturbances. The TPZ incorporates the SRZ, the area required for tree stability.
