**197 CHURCH STREET, PARRAMATTA**

**HERITAGE LETTER - REVIEW UNDER SECTION 8.2 OF THE REFUSAL OF DA/802/2021**

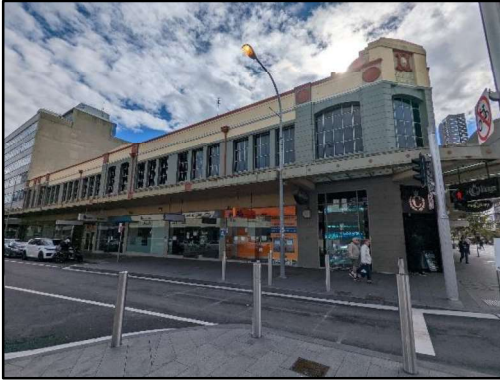
**Figure 1.** External view of the heritage façade of the subject building as viewed from Macquarie Street, facing north-east.

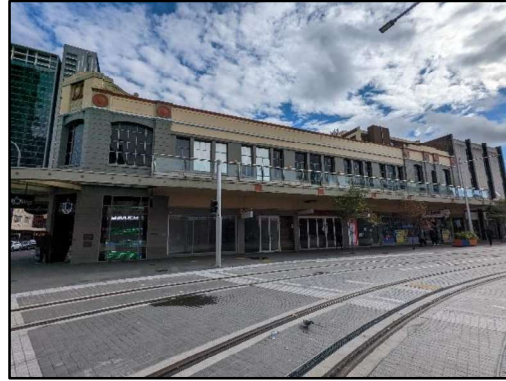
**Figure 2.** External view of the heritage façade of the subject building as viewed from Church Street.

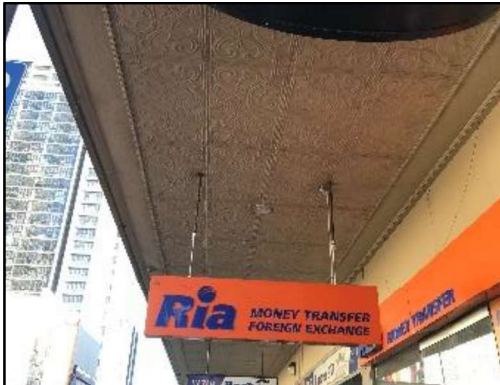
**Figure 3.** External view of the cantilevered awning showing the pressed metal ceiling of the Federation department store as viewed along Macquarie Street.

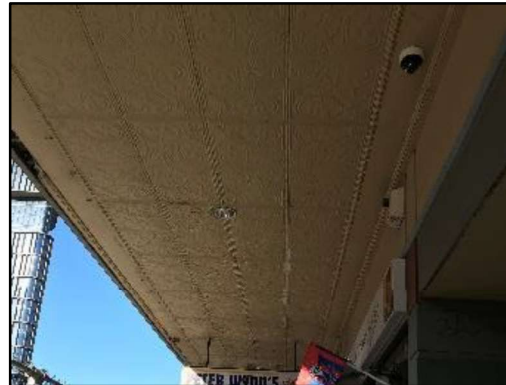
**Figure 4.** External view of the cantilevered awning showing the pressed metal ceiling of the Federation department store as viewed along Church Street.

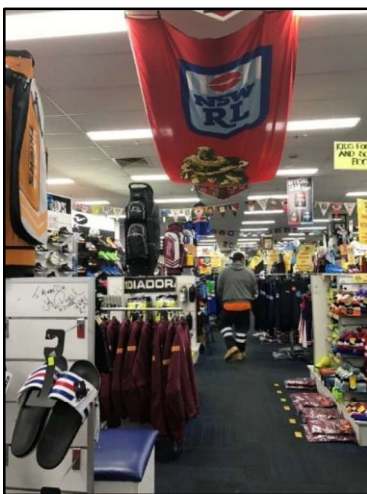
**Figure 5.** Internal view to ground floor shop on the northern side of the Church Street facade. Note the non-original internal fittings and finishes.

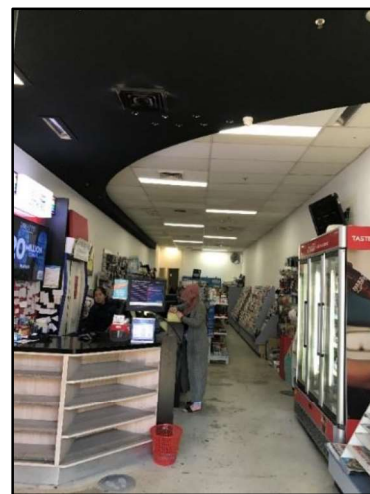
**Figure 6.** Internal view to ground floor shop along Church Street. Note the non-original internal fittings and finishes.

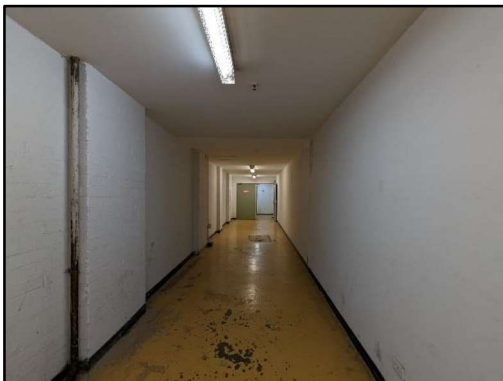
**Figure 7.** Internal view of the service passages on the ground floor showing concrete flooring and suspended ceilings.

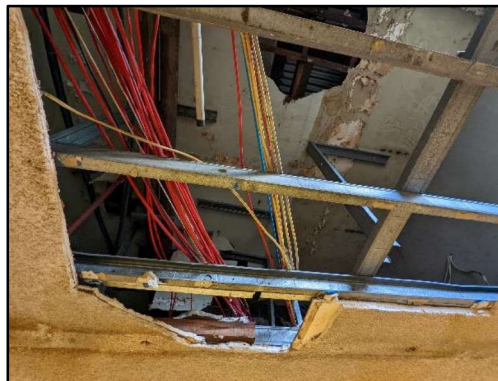
**Figure 8.** Internal view of the ceiling above the later addition suspended ceilings. Note there are no heritage ceilings above.

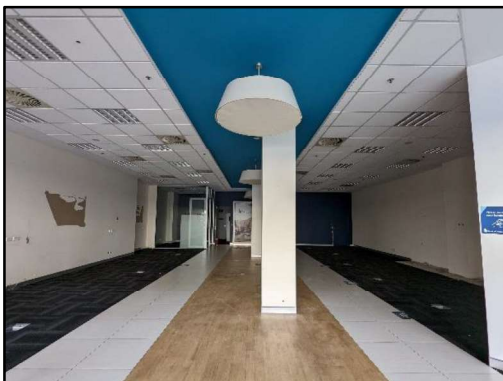
**Figure 9.** Internal view of one of tenancies on ground floor showing non-original fabric.

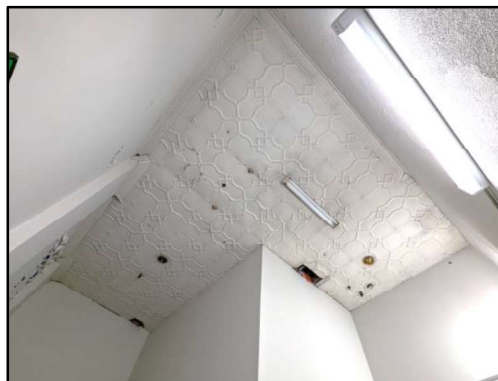
- It must be noted that there is a small remnant panel of pressed metal ceiling within the interior, but this ceiling is in a very poor condition and is isolated from all the surrounding newer fabric (refer to Figure 10 below).

**Figure 10.** Internal view of the decorative ceiling evidenced on the ground floor.

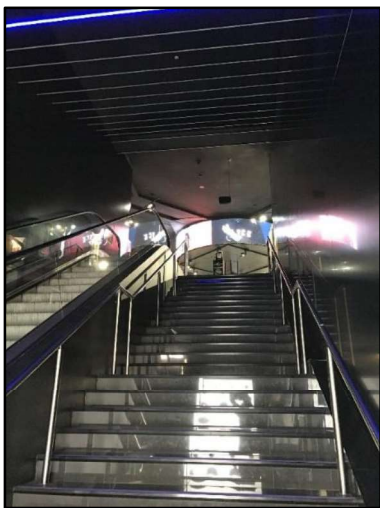
**Figure 11.** Internal view to the stairs leading from the ground floor to the first floor at the entrance at the corner of Church and Macquarie Streets. Note the non-original internal fittings and finishes.

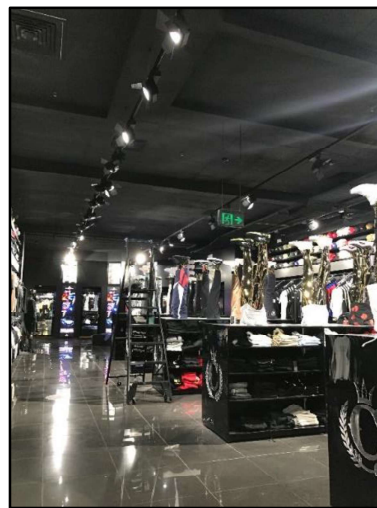
**Figure 12.** Internal view to the first floor. Note the non-original internal fittings and finishes.
