FACADE RETENTION STRATEGY REPORT

# 197 Church Street, Parramatta

Ref: SY212658-  
Rev: A  
Date: 18.03.2022

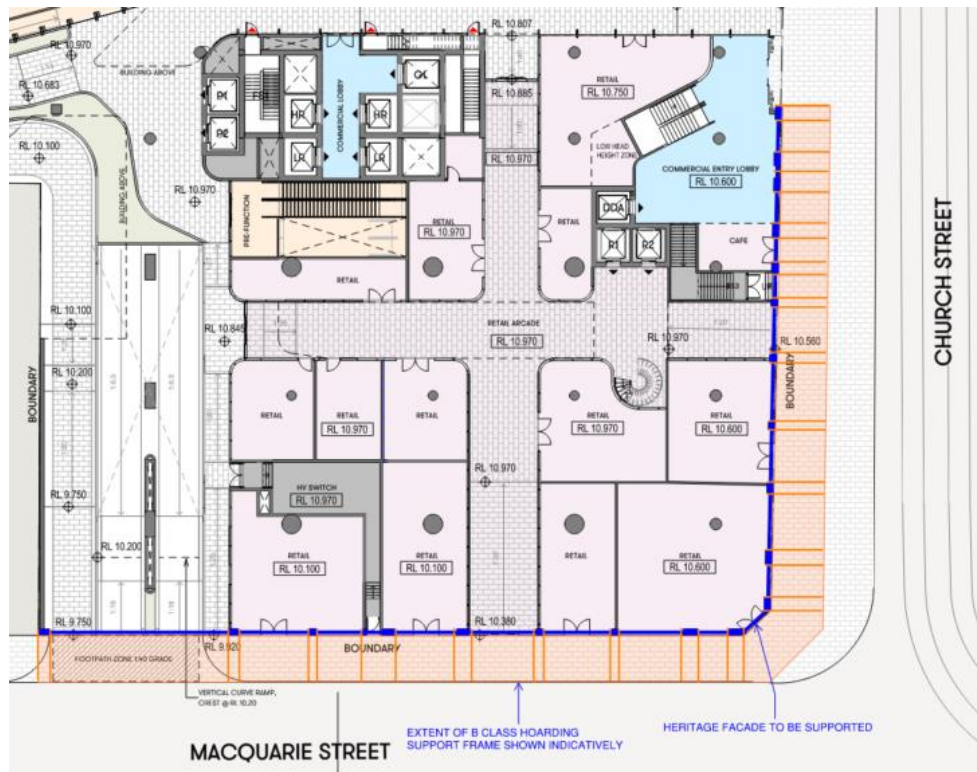
Figure 2: Plan showing facade and indicative Class B hoarding

2. A specifically designed Class B hoarding with extended braced columns is then to be constructed adjacent the heritage façade. The proposed extent of this hoarding is shown in Figure 2. The design of these frames is to be such that the heritage wall can be positively restrained at all window and door opening points, and parapets. The frames must also avoid any decorative elements as nominated by the heritage consultant. Refer Figure 3 for section.
