WASTE MANAGEMENT PLAN

Outline of Proposal				
Site Address: 49 A & 51 NORFOLK ROAD, EPPING				
Applicant's name and address:				
C/- MINTO PLANNING SERVICES				
P.O. BOX 424 BEROWET				
Phone: 9575 4788 Fax:				
Buildings and other structures currently on the site:				
owelline 1 carport				
Brief Description of Proposal:				
suspines of two Lors little of Lors				
The details provided on this form are the intentions for managing waste relating to this project				
Signature of Applicant: Date: 8/1/2

APPENDIX 6
TREE PROTECTION PLAN

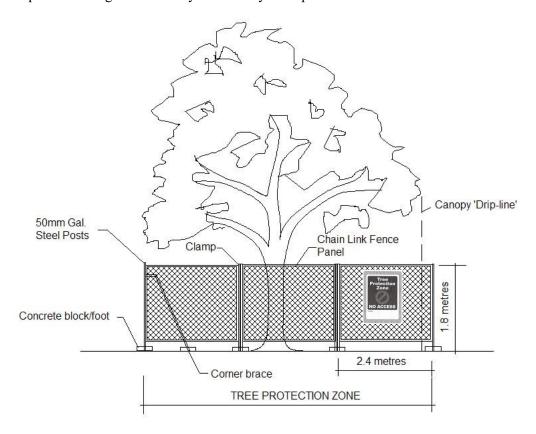
10.5.1 Trees [T5, T6, T7, T9, T10, T16, T17, T18 & T20-T29] shall be protected prior to and during construction from all activities that may result in detrimental impact by erecting a suitable protective fence in the positions as indicated on the Tree Protection Plan (Appendix 6). As a minimum, the fence shall consist of temporary chain wire panels of 1.8 metres in height, supported by steel stakes as required and fastened together and supported to prevent sideways movement using corner braces where required. The fence shall be erected prior to the commencement of any work on-site and shall be maintained in good condition for the duration of construction. Where tree protection zones merge together a single fence encompassing the area is deemed to be adequate. Existing site boundary fences may form part of the enclosure.

Figure 1 – Detail of Tree Protection Fence

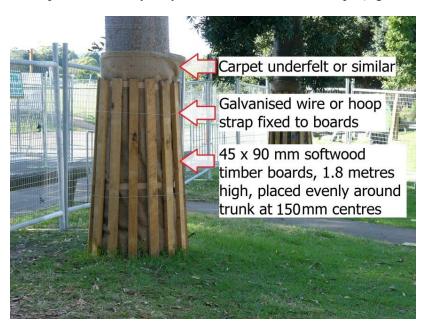
10.6.1 Trunk protection boarding shall be erected around Trees [T38] to avoid accidental damage, as indicated on the Tree Protection Plan (Appendix 6). The trunk protection shall consist of a layer of carpet underfelt (or similar) wrapped around the trunk, followed by 1.8 metre lengths of softwood timbers (90 x 45mm in section) aligned vertically and spaced evenly around the trunk at 150mm centres (i.e. with a 50mm gap) and secured together with 2mm galvanised wire or galvanised hoop strap as shown in Figure 3. Recycled timber (such as demolition waste) may be suitable for this purpose, subject to the approval of the Project Arborist. The timbers shall be wrapped around the trunk (over the carpet underfelt), but not fixed to the tree to avoid mechanical injury or damage to the trunk. Trunk protection should be installed prior to any site works and maintained in good condition for the duration of the construction period. Carpet underfelt (alone) is sufficient for trees with a trunk diameter of less than 200mm. This shall be wrapped around the trunk in a double layer and held in place with heavy-duty fibre reinforced adhesive tape (e.g. Gaffer Tape).

Figure 3 - Detail of Trunk Protection

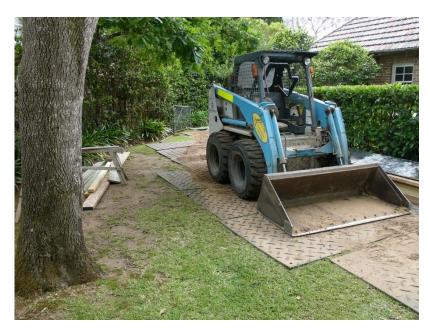
10.7.1 Construction haul routes shall be confined to existing paved areas wherever possible. Where this is not feasible and construction haul routes or access for plant and equipment must traverse soft landscape areas within TPZs of [any tree nominated for retention], 20mm thick marine ply sheets or truck mats (such as Envirex Versadeck® access mats) (refer Figure 4 shall be placed over the top of the ground surface to minimise compaction and disturbance of the underlying soil profile and root zone.

Figure 4 – Showing typical detail for truck mats.

10.7.2 Ground protection shall be installed prior to any site works and maintained in good condition for the duration of the construction period. On completion of the works, ground protection shall be removed without damage or disturbance to the underlying soil profile.

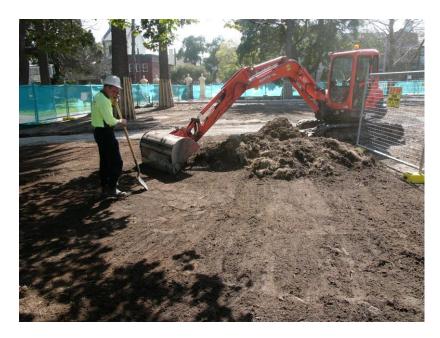
Any residual vegetation (dead grass etc) may then be carefully scraped-off the surface using a small rubber tracked excavator with a broad sand bucket (i.e. without tynes/teeth), taking care to remove the minimum topsoil necessary (no more than 20mm deep) (refer to **Figure 5**). An observer shall be used to ensure that no woody surface roots of any trees are damaged during this process.

Figure 5 – Showing method for removal of residual surface vegetation from Tree Protection Zones following herbicide treatment and slashing.

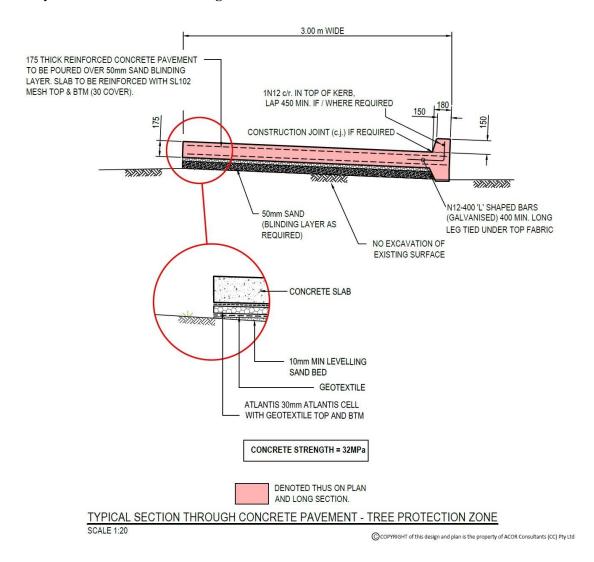
10.12.1 Proposed paved areas within the TPZs of Trees [T1] shall be placed at or slightly above grade where possible to minimise excavations within the root zone and avoid severance and damage of woody roots in accordance with **Figure 7**.

Figure 7 - Conceptual driveway slab detail within TPZ of T1 (Carob Tree). (ref: ACOR Consultants (CC) Pty Ltd).

- 9.1.5 The existing driveway (concrete wheel strips) servicing 49A Norfolk Road is proposed to be demolished and replaced with a new driveway and passing bay within the TPZ of T1 (Carob Tree). In order to minimise excavation and compaction for the pavement sub-grade within the TPZ, the driveway slab is proposed to be elevated and supported on a sand blinding layer, geotextile and strip drainage system. The encroachment to the TPZ is approximately 31%, which exceeds acceptable limits under AS 4970:2009. However, if implemented using the construction methodology as specified, this work will not result in any actual incursion to the root zone and therefore the proposed works will not result in any adverse impact on this tree. The geotextile layer will limit the degree of compaction and the strip drain will permit some moisture penetration and aeration to the root zone. In order to avoid any adverse impact, the existing concrete wheel strips should be demolished in accordance with Section 10.8. The new driveway slab should be installed above grade as detailed in accordance with Section 10.12. Any required excavation for the new pavement sub-grade within the TPZ should be undertaken in accordance with Section 10.9.

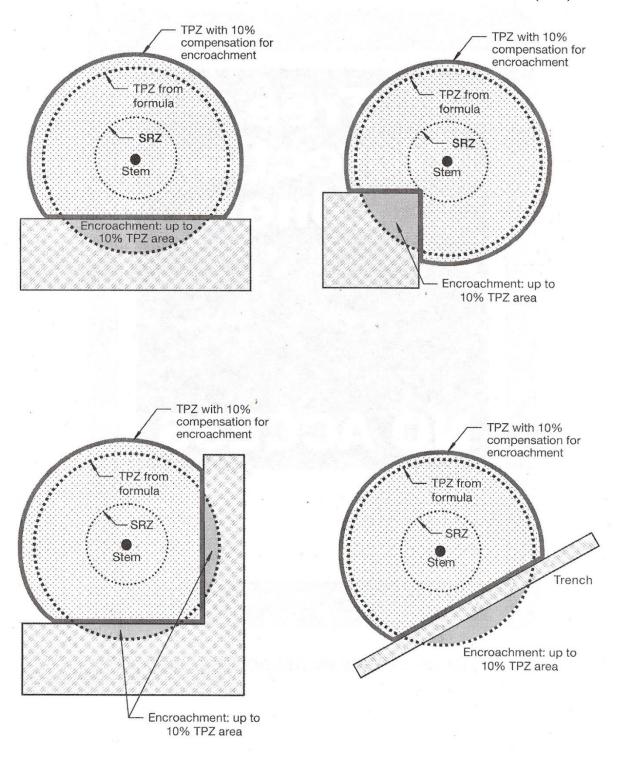
APPENDIX 2 – ACCEPTABLE INCURSIONS TO THE TREE PROTECTION ZONE (TPZ)

NOTE: Less than 10% TPZ area and outside SRZ. Any loss of TPZ compensated for elsewhere.

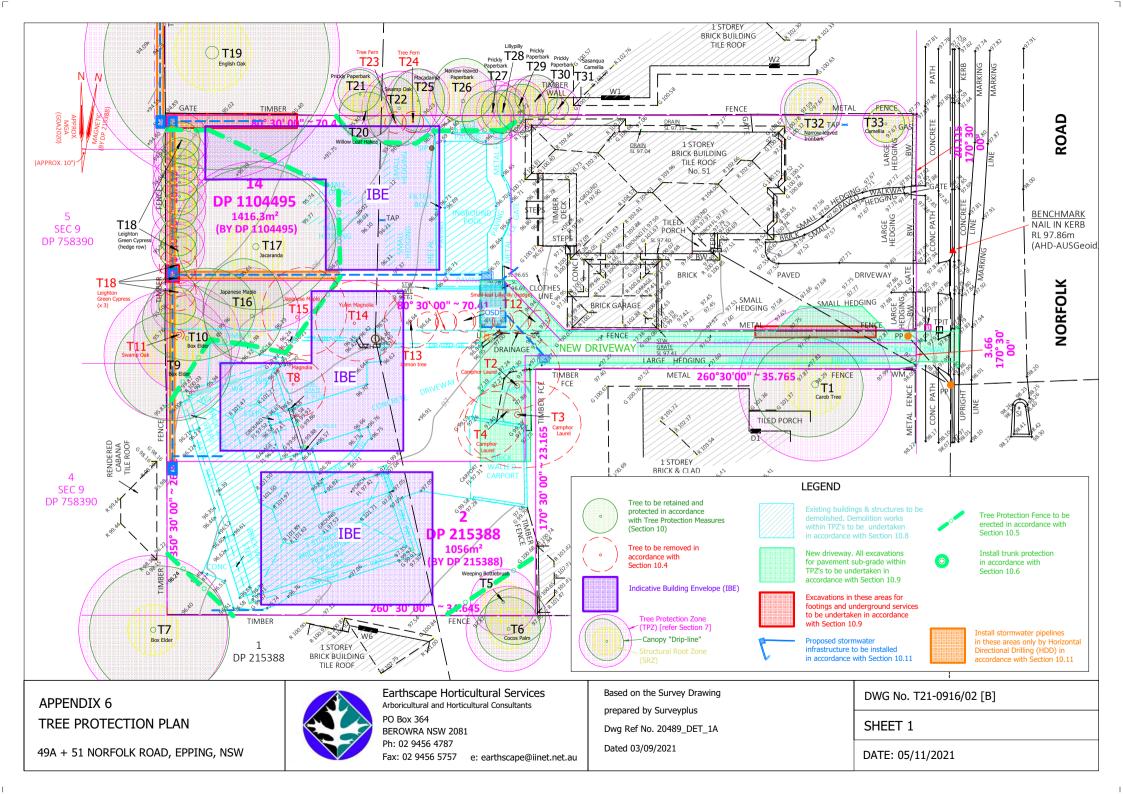
T25 Paperbark T21/ TIMBER Earthscape Horticultural Services Based on the Survey Drawing DWG No. T21-0916/02 [B] APPENDIX 6 Arboricultural and Horticultural Consultants prepared by Surveyplus PO Box 364 TREE PROTECTION PLAN SHEET 2 Dwg Ref No. 20489_DET_1A BEROWRA NSW 2081 Ph: 02 9456 4787 Dated 03/09/2021 49A + 51 NORFOLK ROAD, EPPING, NSW DATE: 05/11/2021 Fax: 02 9456 5757 e: earthscape@iinet.net.au

10.1.1 The following Tree Protection Measures should be read in accordance with the Tree Protection Plan (**Appendix 6**). The Tree Protection Plan (TPP) indicates the position of tree protection devices and other recommended measures to ensure the protection of trees within the site to be retained as part of the proposed development.
