Nimbus Architecture & Heritage

Soil Permeability as per AS1547-2012

No 11 Haines Avenue Carlingford New South Wales

AS2870-2011 SITE CLASSIFICATION

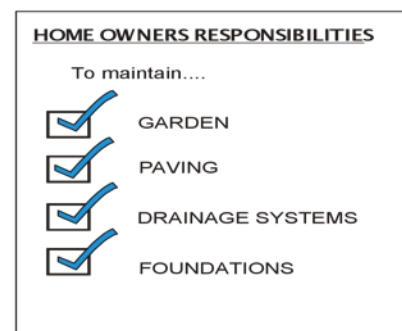
Fig.7

The home owner should read and become familiar with the Site Classification report provided prior to construction and the type of footing system used in the building. To comply with Australian Standard 2870 – "Residential slabs and footings", and achieve acceptable performance and safety during the design life of the house, the owners shall maintain the garden and foundation soil moistures, paving and drainage systems. (Fig. 7)
