LAKE PARRAMATTA

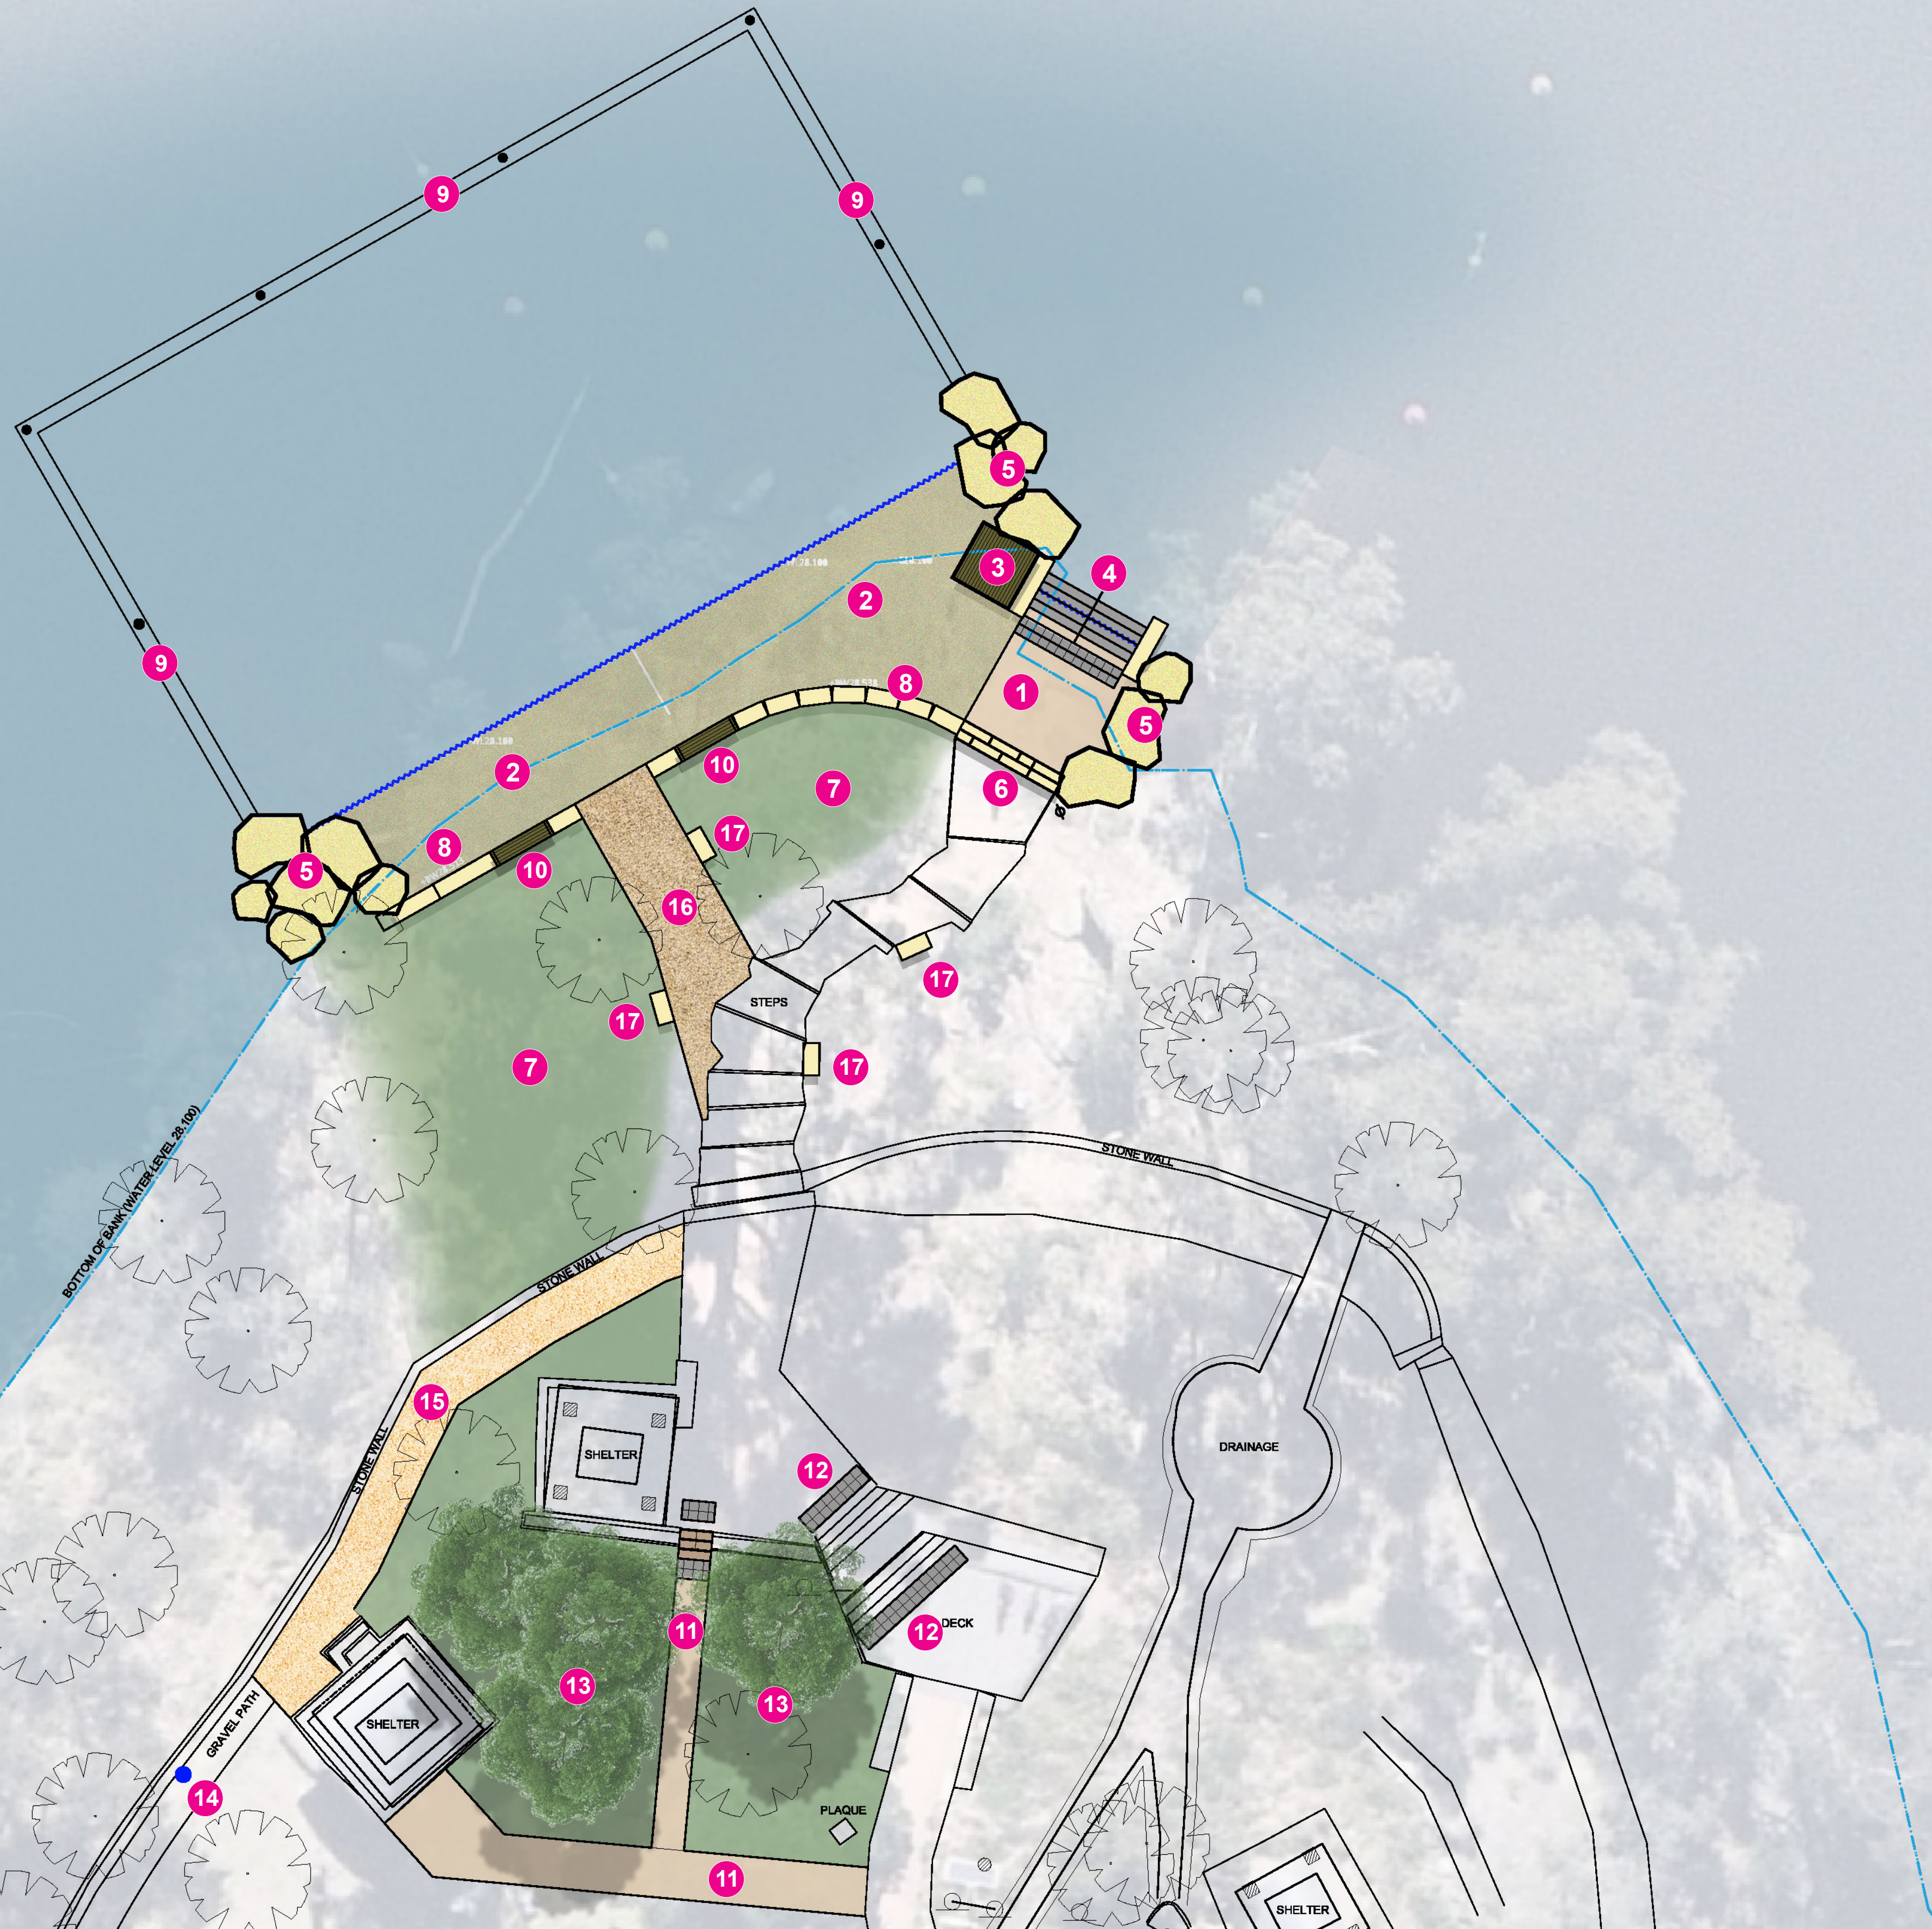
- 1** - Coloured concrete pavement to improve accessibility to waters edge
- 2** - Coarse river sand 'beach' for improved level water access
- 3** - 2.0 x 2.0m raised mod-wood lifeguard platform

- 4** - Concrete water access steps with central stainless steel handrail and tactile surface indicators
- 5** - Proposed sandstone rock outcrops / boulders

- 6** - Sandstone coloured concrete steps to match existing
- 7** - Planted native bush regeneration works
- 8** - Sandstone block seating / retaining wall

- 9** - Underwater retaining wall to 1.8m depth with depth markers to retain coarse river sand 'beach' material
- 10** - Backrest and armrests placed on sandstone block retaining wall

- 11** - Coloured concrete access pathway with steps and tactile surface indicators along pedestrian desire line improving accessibility to existing shelters and swimming area

- 12** - Tactile surface indicators placed at the top and bottom of existing deck steps for improved accessibility
- 13** - Planted native bush regeneration works including 75L pot sized endemic 'Black Butt' shade tree planting

- 14** - Potential location for water refill station
- 15** - Improved access with widened decomposed granite pathway
- 16** - Informal crushed sandstone pathway and swimming area maintenance access

- 17** - Sandstone block bench seating rest spots
